OREGON CORNER RESTORATION FORM

Section 5 Township 3N Range 28E
 County Umatilla Date: 07-05-02

Corner Designation: 3N28A9

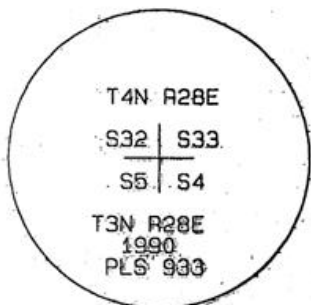
DIAGRAMS

Found the brass cap as described below.

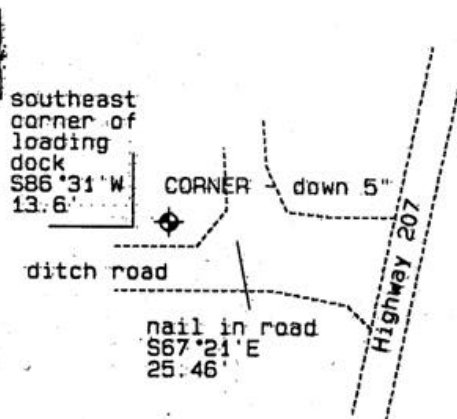
SKETCH

From the junction of I84 and Highway 207, go south on Highway 207 1.5 miles. Turn into a driveway westward and go 2'. The corner is in the northwest corner of the driveway intersection.
