# OREGON CORNER RESTORATION FORM

Section 30 Township 3N Range 28E  
 County Umatilla Date: 06-14-02

Corner Designation: 3N28V1

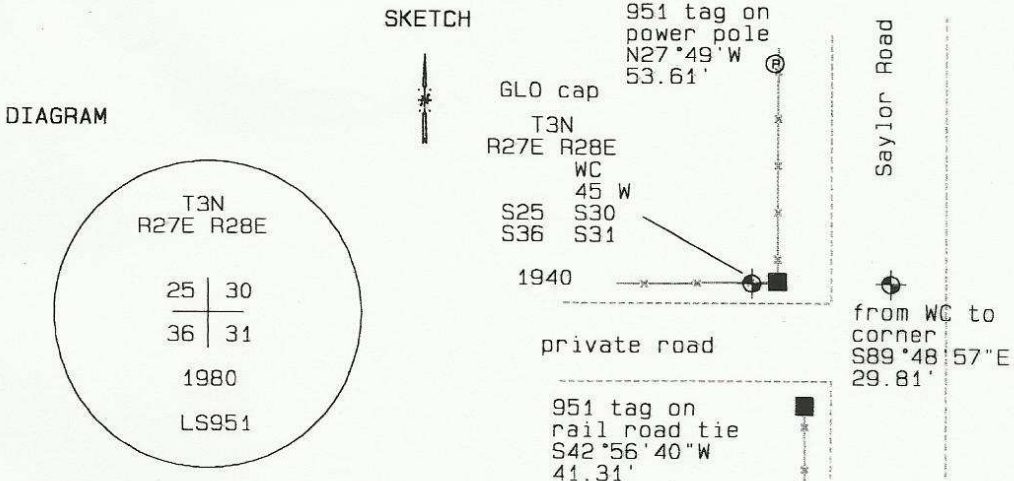
Found a brass capped monument stamped as shown on the drawing in good  
 condition 6" below the surface of the road.
