OREGON CORNER RESTORATION FORM

Corner Designation: 3N29L13

1/4 Corner common to sections 15 and 16, T3NR29E.

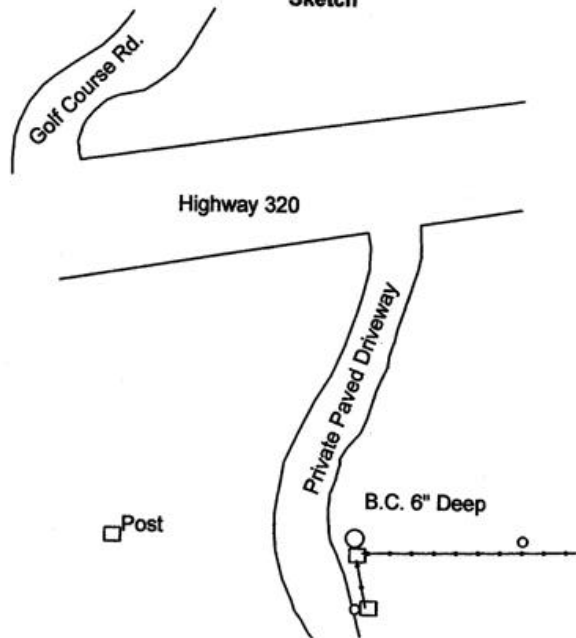
Sketch

Found A 2.5" B.C.

Found B.O. Tag on a RR Tie fence post S 86°30' E, 38.00'.

Found B.O. Tag on a RR Tie fence post S, 0.30'.

A 3/8" x 30" Iron rebar w/ypc #43406 lies S 16°00' E, 6.59'.

A 3/8" x 30" Iron rebar w/ypc #43406 lies N 87°15' E, 24.98'.
