OREGON CORNER RESTORATION FORM

Section: 2, 35 Township: 3N, 4N Range: 33E
County: Umatilla Date: 3/25/2011

Corner Designation: 3N33A19 (Amended 4/3/2012)

Quarter corner common to Sections 2, T3NR33E; 35, T4NR33E.

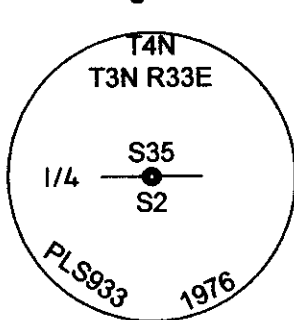
Diagram

A 2 1/2" brass cap, stamped as shown below, 4" below the surface.
A 5/8" iron rebar lies N 43° 40' E, 41.73', at a power pole.

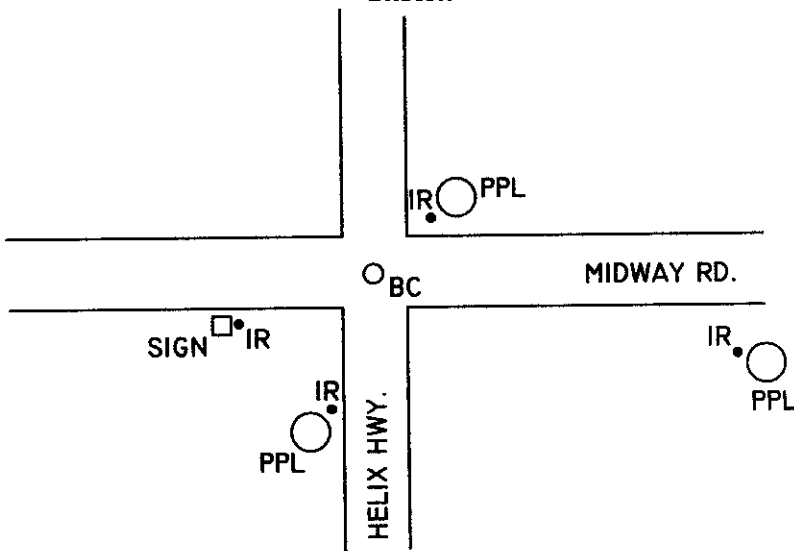
Sketch

- A 5/8" x 30" iron rebar w/RPC #43406 lies S 78° E, 90.66', at a power pole.
- A 5/8" x 30" iron rebar w/RPC #43406 lies S 20° 20' W, 64.06', at a power pole.
- A 5/8" x 30" iron rebar w/RPC #43406 lies S 71° 30' W, 60.70', at a stop sign.

The corner is located in the intersection of Midway Rd. and the Helix Hwy.
