OREGON CORNER RESTORATION FORM

Section: 2, 3 Township: 3N Range: 33E
County: Umatilla Date: 3/23/2011

Corner Designation: 3N33C17 (Amended 4/2/2012)

Quarter corner common to Sections 2, 3, T3NR33E.

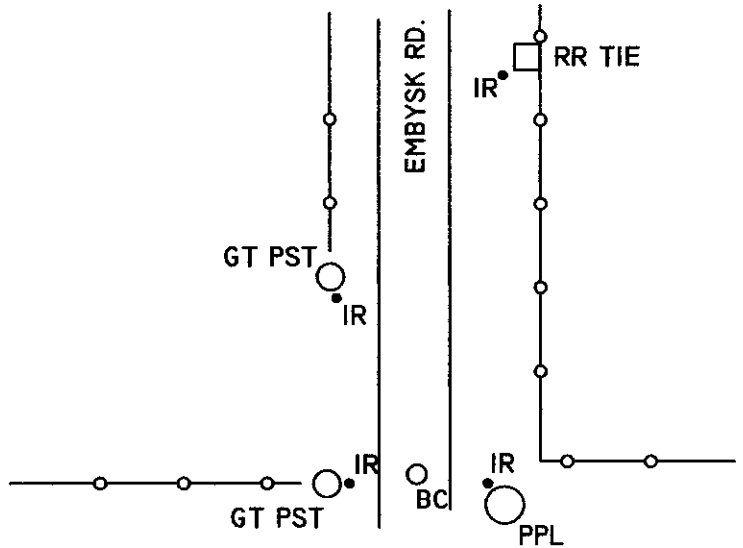
Sketch

None.

A 1 1/8" x 30" galvanized iron pipe with a 2 1/2" brass cap, stamped as shown above, 10" below the surface. The corner was reestablished by holding an ancient East-West fence line for Northing and by holding the line between found corners to the North and South for Easting.

- A 5/8" x 30" iron rebar w/ RPC #43406 lies N 19° W, 34.25', at a gate post.
- A 5/8" x 30" iron rebar w/ RPC #43406 lies N 19° 15' E, 68.70', at a railroad tie post.
- A 5/8" x 30" iron rebar w/ RPC #43406 lies S 88° E, 24.74', at a power pole.
- A 5/8" x 30" iron rebar w/ RPC #43406 lies S 86° W, 9.86', at a gate post.
