OREGON CORNER RESTORATION FORM

Township: 3N
Date: 2/14/2011

Corner Designation: 3N33E17

Section corner common to Sections 2, 3, 10, 11, T3NR33E.

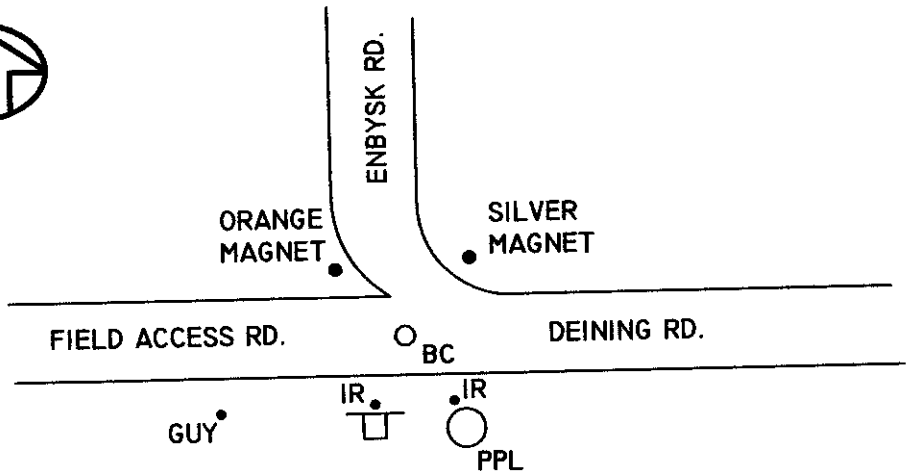
Sketch

A 2 1/2" brass cap, stamped as shown below.

- "Deep One" magnets by Berntsen.
- An orange magnet lies N 43° 50' W, 42.82', 13" deep.
- A silver magnet lies N 30° 40' E, 41.15', 14" deep.
- A 5/8" iron rebar w/RPC #43406 lies S 30° 30' E, 20.24', at a power pole.
- A 5/8" iron rebar w/RPC #43406 lies S 18° 10' W, 15.63', at a road sign.
