OREGON CORNER RESTORATION FORM

Section: 20, 21, 28, 29 Township: 3N Range: 33E
County: Umatilla Date: 3/4/2011

Corner Designation: 3N33R09 (Amended 3/12/2012)

Section corner common to Sections 20, 21, 28, 29, T3NR33E.

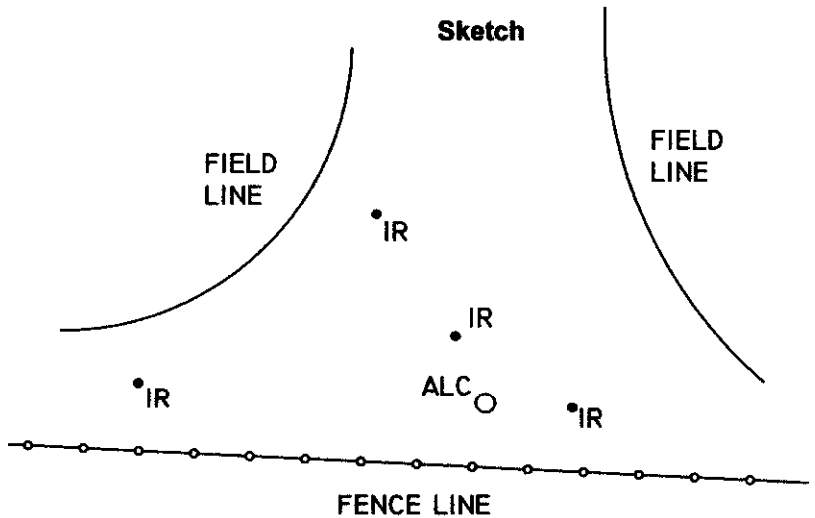
Sketch

- A 2" aluminum cap.
- A 5/8" iron rebar w/RPC #1106 lies N 89° 30' W, 76.5'.
- A 5/8" iron rebar w/RPC #1106 lies N 30° W, 64.7'.
- A 5/8" iron rebar w/RPC #1106 lies N 24° W, 24.0'.
- A 5/8" iron rebar w/RPC #1106 lies S 87° E, 22.5'.
