OREGON CORNER RESTORATION FORM

Section: 25, 36, 30, 31 Township: 3N Range: 32E, 33E
County: Umatilla Date: 2/11/2011

Corner Designation: 3N33V01

Section corner common to Sections 25, 36, T3NR32E; 30, 31, T3NR33E.

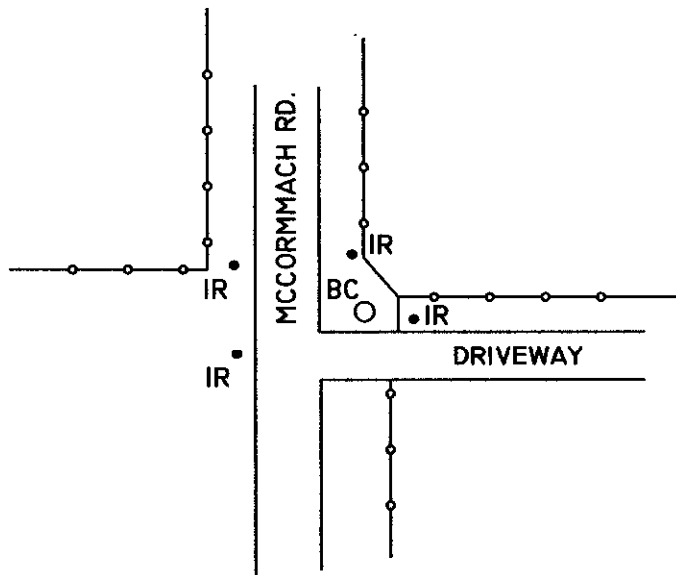
Sketch

A 2 1/2" brass cap.
A 5/8" iron rebar w/RPC PLS 953 lies N 68° 30' W, 48.74'. Haddock found this accessory at N 68° 09' 26" W, 48.73' in V1-01-81C.
A 5/8" iron rebar w/RPC PLS 953 lies S 63° 30' W, 51.55'. Haddock found this accessory at S 63° 58' 48" W, 51.58' in V1-01-81C.

A 5/8" x 30" iron rebar w/RPC #43406 lies S 87° 30' E, 22.37', at a steel fence post.
A 5/8" x 30" iron rebar w/RPC #43406 lies N 27° W, 23.92', at a wooden gate post.
