OREGON CORNER RESTORATION FORM

Section 3 Township 3N Range 28E
 County Umatilla Date: 06-14-02

Corner Designation: 3N28A13

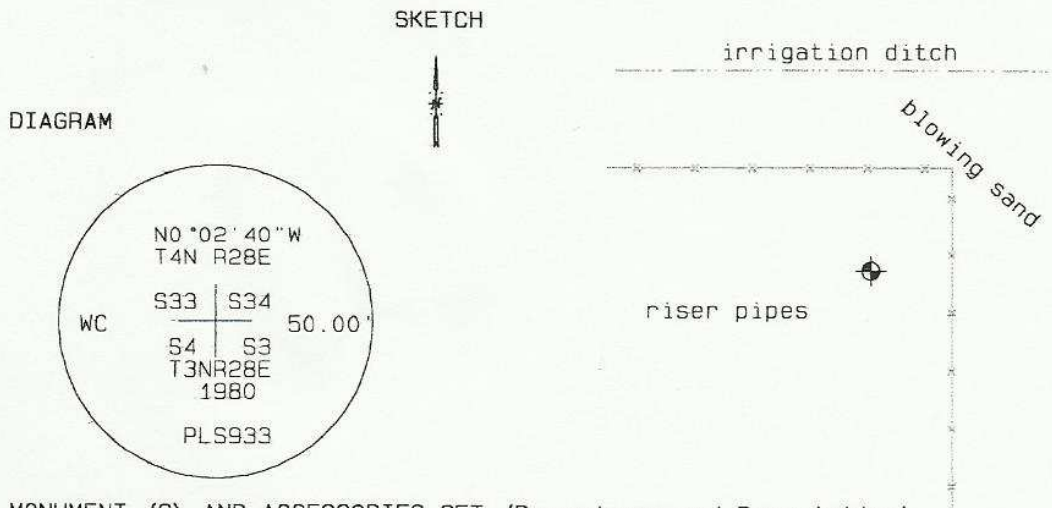
Monument and Accessories Found: (condition and source)
 Found the monument loose on the ground about 50 feet southwest of a fence corner near an irrigation structure. The area is subject to blowing sand erosion.
