OREGON CORNER RESTORATION FORM

Section 36 Township 5 N Range 34 E

County Umatilla Date 1-27-88

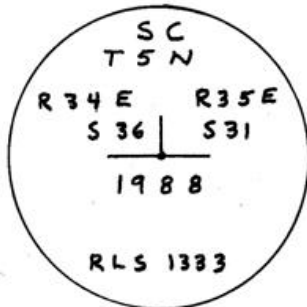
Monument Detail

Set 1" x 30" G.I.P. w/flared base and 2 1/2" brass cap 6" above the ground abutting the east face of a wood R.R. tie fence post. Witness monuments are referenced from true position of section corner not the B.C. The B.C. is 0.08 ft. east of true position

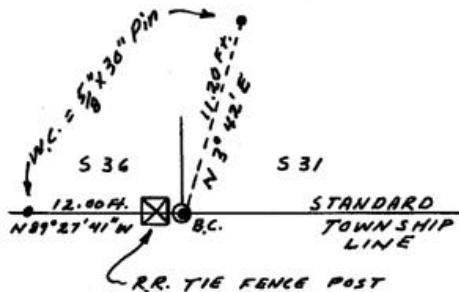
Sketch

Found old fence line and plowline running west and plowline running north from an old RR tie fence post marking the section corner location. The RR tie fence corner post was used in the Krumbein survey, Map # M-27-B.

A witness monument bears N 89° 28' W - 12.00 Ft.
A witness monument bears N 3° 42' E - 11.20 Ft.
Witness monuments are 5/8" x 30" rebar with red plastic caps marked R.L.S. 1333. Set steel fence post near each W.C. and B.C. with yellow witness signs attached.
