OREGON CORNER RESTORATION FORM

Section 1 Township 1S Range 32E

County Umatilla Date 7/13/87

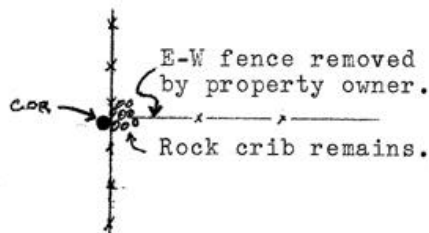
Sketch

North-South fence line and mound of rock from rock crib which exists from the remains of an east-west fence. According to Joe Miller, property owner, the east-west fence existed for many years before he removed it. Corner area is completely surrounded by wheat fields. Bearing and distance to monumented SE corner of Section 1 checks within reason. I accept the corner of the north-south fence and remains of the fence from the east as the best remaining evidence of the original corner location.

Set 1" I.D. by 30" long G.I.P. w/ flared leg and 2 1/2" brass cap 22" in the ground and surrounded with a mound of stone.

A reference monument bears S3°E-9.1 feet.
A reference monument bears N3°W-11.5 feet.
Reference monuments are 5/8" by 30" rebar with 1 1/2" alum. caps marked "RM" with the distance to the corner. Set steel fence posts near each RM with bearing object and cor. signs attached.
