OREGON CORNER RESTORATION FORM

Section 9 Township 2N Range 33E

County Umatilla Date Jan. 1994

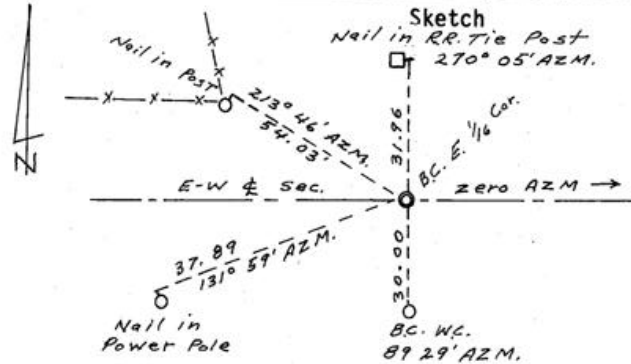
Monument Detail

Found 2 1/2" brass cap W.C. on 1" pipe 30.00 ft. south of corner.

Set 2 1/2" brass cap on 1" x 30" G.I.P. 6" below paving surface in a C.I. monument box with lid.

New Accessories 1. Set alum. nail in middle of a bearing object sign on N.W. face of power pole S. W. 37.89 ft. from the corner.

2. Set alum. nail in middle of a bearing object sign on N. E. face of fence post N. W. 54.03 from the corner.

3. Set alum. nail in middle of a bearing object sign on E. face of R.R. tie fence post N. 31.96 ft. from the corner.
