OREGON CORNER RESTORATION FORM

Section 9 & 10 Township 2 N Range 33E

County Umatilla Date Jan. 1994

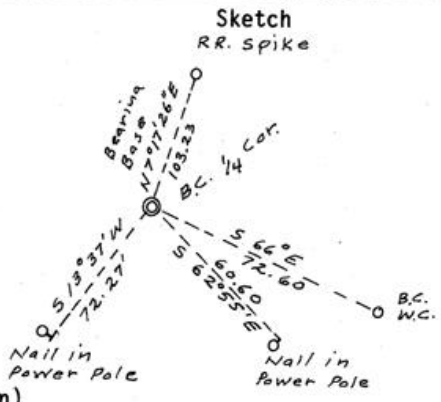
Monument Detail

Found $2\frac{1}{2}$ " brass cap W. C. on 1" pipe stamped "N 66° 00' W 72.60' W.C."

Found R.R. spike in paving N 7° 17' 26" E. 103.23 ft. from the corner.

Set $2\frac{1}{2}$ " brass cap on 1" x 30" G.I.P. 6" below paved surface in a C.I. monument box with a lid.

1. set alum. nail in middle of bearing object sign on N.E. face of power pole S.E. 60.60 ft. from corner
2. Set alum. nail in middle of bearing object sign on E. face of power pole S. W. 72.27 ft. from the corner
