FOREST SERVICE

Umatilla NATIONAL FOREST ✓

CORNERS OF THE PUBLIC SURVEY

T. 2 N R. 37 E W Mer.

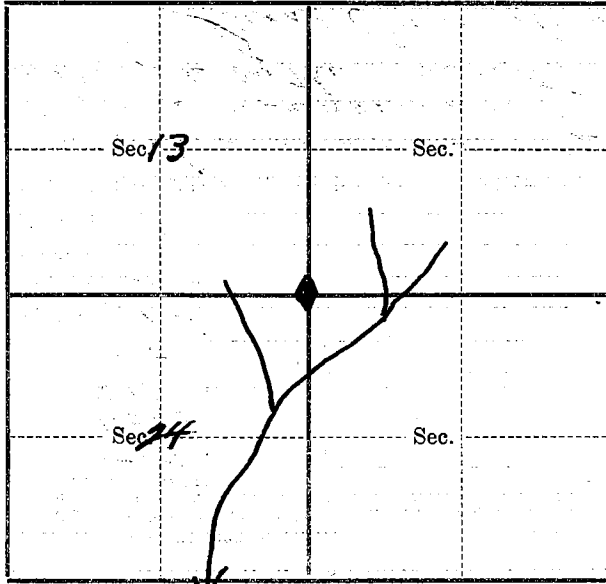
(Make sketch of topography near Corner)

Corner consists of a Stake rotted (not) in place

If not, why? Corner was probably a stake and has been destroyed by the elements.

Metal Location Poster is on a Y.P.
tree 18 inches diameter, on the North
side of Corner
from which this Corner bears South 10° W
One chains distant.

Near the headwaters of
Willow Creek on Township
line between Township
2 North and Range 37 and
38 E.N.M. East of course &
about 100 yds from creek
