OREGON CORNER RESTORATION FORM

Section 1 Township 3N Range 27E
 County Umatilla Date: 06-29-02

Corner Designation: 3N27E23
 Condition Report Only
 Not Found
 Remonumented
 Unrecorded
 Surveyed In
 Referenced Out

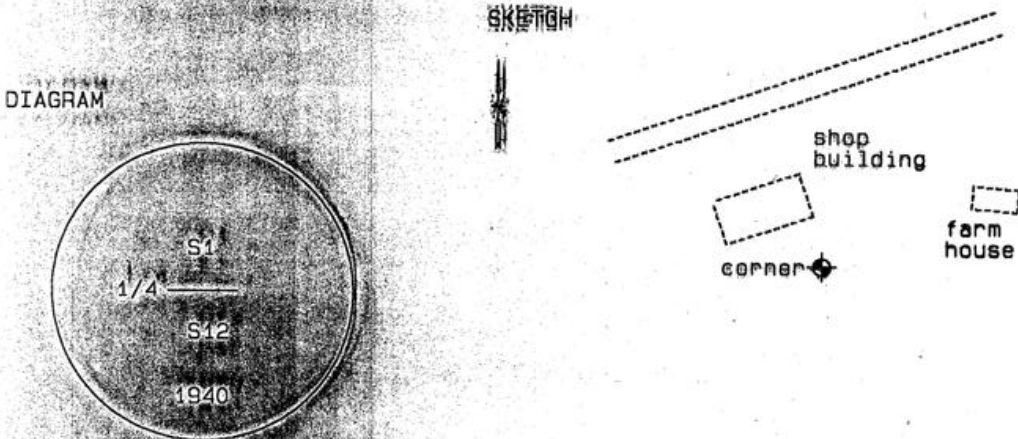
Found the described GLO brass capped monument as described south of the east end of a steel farm building.
