# OREGON CORNER RESTORATION FORM

Section 8 Township 3N Range 28E  
 County Umatilla Date: 07-19-02

Corner Designation: 3N28J9

_____X_____	Condition Report Only
_____	Not Found
_____	Re-monumented
_____	Unrecorded
_____	Surveyed In
_____	Referenced Out

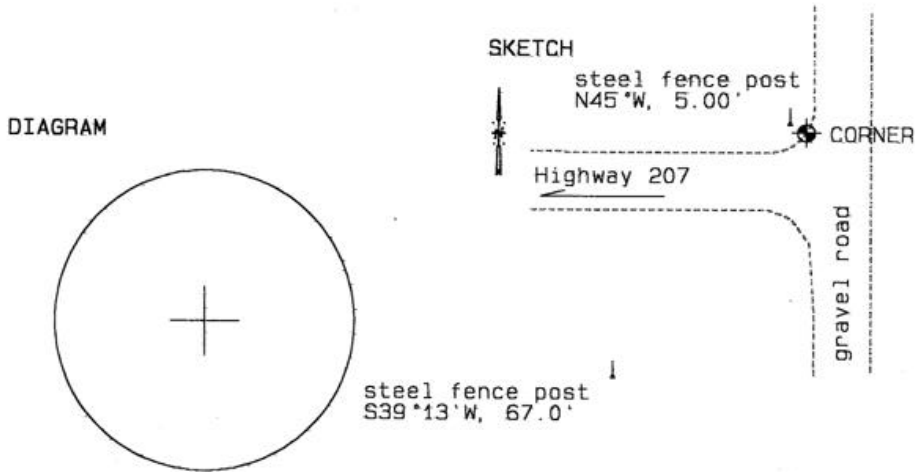
Found the pipe in good condition as shown in the sketch below.  
 Pipe is down 2" at edge of road where traffic runs over it.
