OREGON CORNER RESTORATION FORM

Section 15 Township 3N Range 28E
 County Umatilla Date: 06-20-02

Corner Designation: 3N28N15

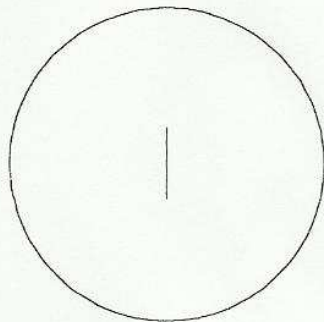
DIAGRAM

Found a 2 1/2" iron pipe at the corner of a three way fence intersection.
