**OREGON CORNER RESTORATION FORM**

Section 21,28 Township 3N  
County Umatilla Date: 8/11/10

Corner Designation: 3N29R11

1/4 corner common to sections 21 and 28 T3NR29E.

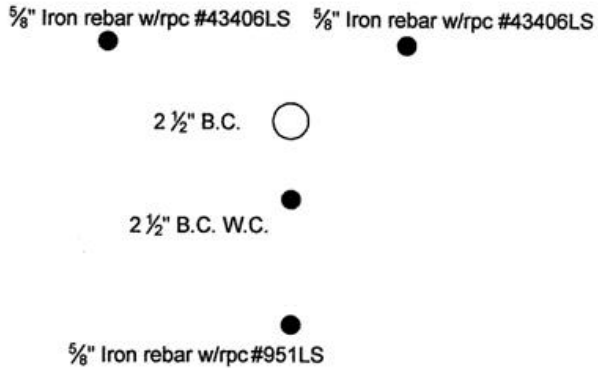
**Sketch**

- A 2 1/2" Brass cap, approx. 12" out of ground at Staebler's called position.
- A 5/8" Iron rebar w/rpc #951 lies S 10°15' E, 216.08'.
- A 2 1/2" Brass cap lies S 28° E, 84.38'. Set by Edwards using double proportionate method.

- A 5/8" x 30" Iron rebar w/rpc #43406LS lies N 56°20' W, 17.24'.
- A 5/8" x 30" Iron rebar w/rpc #43406LS lies N 28°30' E, 19.36'.

This corner falls on a Wly slope at the W edge of Piercy's Vineyard. Inside the vineyard fence.
