OREGON CORNER RESTORATION FORM

Date: 01/15/10

Corner Designation: 3N29Z13

Corner common to sections 33,34 T3NR29E, 3,4, T3NR28E.

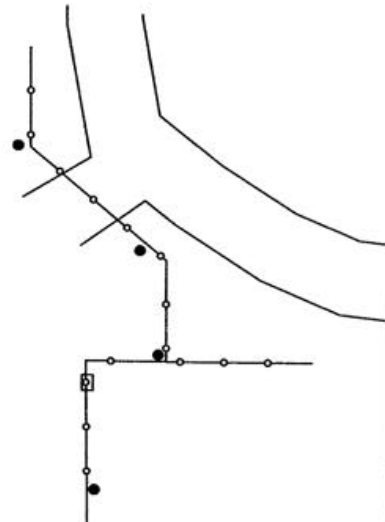
Sketch

An Iron Pipe w. a 5" x 8" steel plate w/ an +, and a N for North.

A ^{5/8"} Iron rebar w/ypc 951LS lies S 4°15' E, 33.88'.

A ^{5/8"} Iron rebar w/ypc 951LS lies N 85°45' E, 48.19'.

A ^{5/8"} Iron rebar w/ypc 951LS lies N 18°45' E, 37.92'.

A ^{5/8"} Iron rebar w/ypc 951LS lies N 17°20' W, 99.52'.
