OREGON CORNER RESTORATION FORM

Section: 29, 30, 31, 32 Township: 3N Range: 33E
County: Umatilla Date: 9/29/2011

Corner Designation: 3N33V05

Section corner common to Sections 29, 30, 31, 32, T3NR33E.

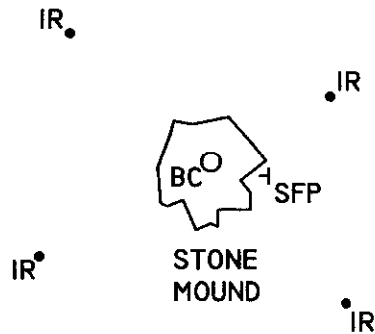
Sketch

A 2 1/2" brass cap, stamped as shown below, 5" above the surface of a stone mound, with a steel fence post 1.4' to the East.
 A 5/8" iron rebar w/RPC #852 lies N 43° 24' 26" W, 29.09'.
 A 5/8" iron rebar w/RPC #852 lies N 60° 56' 05" E, 21.64'.
 A 5/8" iron rebar w/RPC #852 lies S 60° 31' 57" W, 32.34'.
 A 5/8" iron rebar w/RPC #852 lies S 44° 12' 12" E, 32.32'.

Replace witness post sign.
