OREGON CORNER RESTORATION FORM

Section: 33, 34 Township: 3N Range: 33E
County: Umatilla Date: 2/17/2011

Corner Designation: 3N33Z13

Section corner common to Sections 33, 34, T3NR33E.

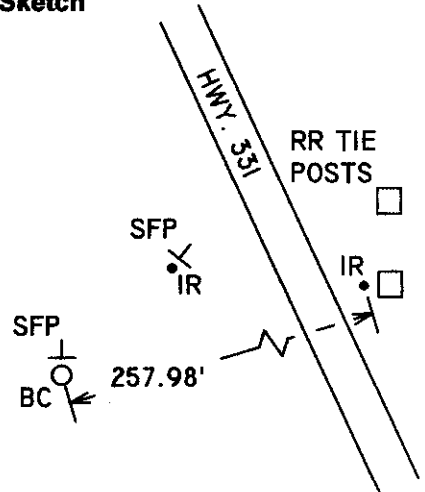
Sketch

A 2 1/2" brass cap, stamped as shown below.
A 2 1/2" brass cap for the Section corner common to Sections 3, 4, T2NR33E lies S 89° 30' W, 123.40'

A 5/8" x 30" iron rebar w/RPC #43406 lies N 24° 45' W, 68.73', at a power pole.
A 5/8" x 30" iron rebar w/RPC #43406 lies N 46° E, 32.08', at a steel fence post.
A 5/8" x 30" iron rebar w/RPC #43406 lies N 73° E, 257.98', at a railroad tie gate post.
