OREGON CORNER RESTORATION FORM

Section: 3, 34 Township: 3N, 4N Range: 33E
 County: Umatilla Date: 3/24/2011

Corner Designation: 3N33A15

Quarter corner common to Sections 3, T3NR33E; 34, T4NR33E.

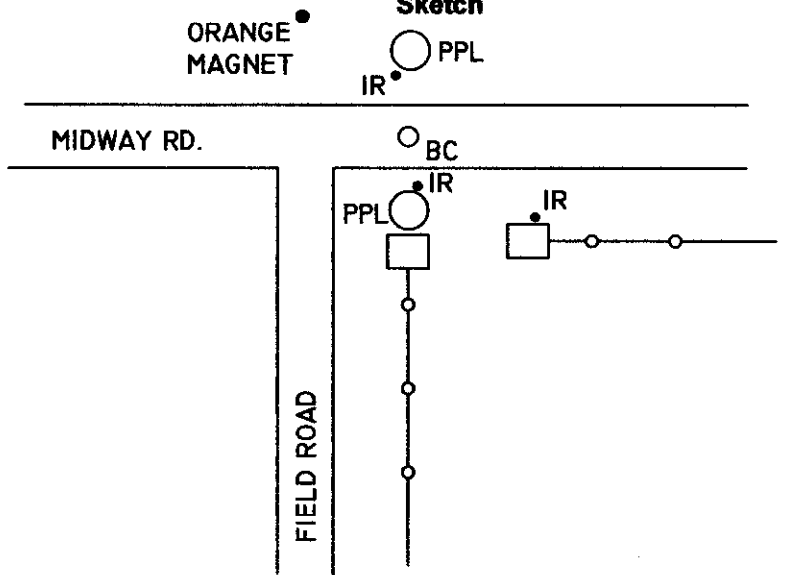
Sketch

None.

A 1 1/8" x 30 galvanized iron pipe with a 2 1/2" brass cap, stamped as shown above, 1.1' below the surface. The corner location was reestablished at the intersection of the line between found corners to the East and West and the projection of an old fence line from the South. This is the best available evidence of the original corner location.

- "Deep One" magnet by Berntsen.
- An orange magnet lies N 42° 50' W, 39.38', 1.6' deep.
- A 5/8" x 30" iron rebar w/RPC #43406 lies N 3° W, 30.29', at a power pole.
- A 5/8" x 30" iron rebar w/RPC #43406 lies S 65° E, 38.57', at a gate post.
- A 5/8" x 30" iron rebar w/RPC #43406 lies S 4° E, 15.24', at a power pole.
