OREGON CORNER RESTORATION FORM

Section 31,32,5,6

County Umatilla

Corner Designation: 3N33A5

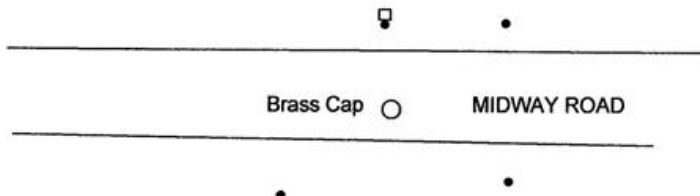
Sketch

A 1 1/4" x 30" galvanized iron pipe with a 2 1/2" brass cap, stamped as shown above, 12" below the surface. There are railroad tie posts every half mile that have been held as boundary lines as evidenced by field lines. I find this to be the best available evidence of the original corner position for Easting locations.

- A 5/8" x 30" iron rebar w/rpc #43406, lies N 0°20' W, 16.94', at a RR Tie.
- A Silver magnet, 17" deep, lies N 45° E, 21.58'.
- A Pink magnet, 18" deep, lies S 29° E, 30.76'.
- A Blue magnet, 20" deep, lies S 34°50' W, 33.97'.
