CORNER RECORD (SEARCH)

Index File No. A-5
T 5S R. 33E
Merid. Willamette

Tract or Survey No. 5-32 Cor. No. A-5

R.D. Ukiah County Umatilla
N.F. Umatilla State Oregon

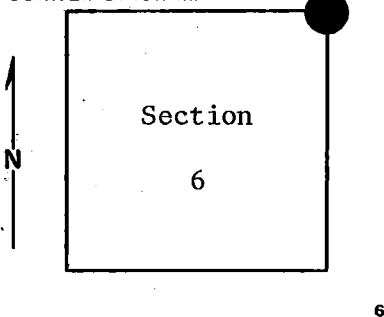
CORNER DIAGRAM

Material: Stone Mound. Size: Mound 5 foot diameter, 1 foot deep.
Brass Cap! See Mon. File,
One foot above ground; fair to poor condition.
Stone mound is somewhat scattered.

An 18 inch p.pine bears S10⁰E, approximately 40 feet in bottom of small drainage--used for fence corner. Scribed T5S, R33E, S5.

A 30 inch p.pine bears approximately due north about 65 feet. Six feet west of bottom small drainage. Has been chopped on. May be B.T. No scribing visible.

A 30 inch p.pine bears S54⁰W, approximately 40 feet. (cont. block 12)

Corner sets 8 feet west of bottom of small drainage. Approximately 200-300 yards west of primitive road. There is a fence running west from corner (slightly south of line). Also, trace of old fence running south.

Has old scar. Could be B.T.

A location poster on 10-inch p.pine bears S10⁰E, 18 feet, bottom of drainage.

I placed blank B.T. poster on B.T. in Section 5.
