USDA-FOREST SERVICE

CORNER RECORD (SEARCH)
(Ref. FSM 7151.4)

T 5S R. 30E R.D. NORTH FORK J.D. County UMATILLA

Merid. WILLAMETTE N.F. UMATILLA State OREGON

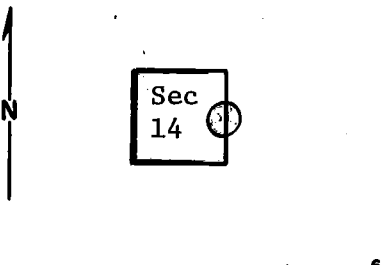
CORNER DIAGRAM

None

North-south fence (Forest boundary). At south edge of open area stands a 14" p. pine (12 ft. west of fence) with (SR) brand on east face. 10 ft. east of fence there is a 6" p. pine, down and rotten, with a very old location poster on it. 12 ft. east of fence, there stands a 6" p.pine with an old Forest boundary metal tag on east face. (cont. in block 12)

5 ft. east of fence stands a 6" p.pine with Pilot Rock Lumber Co. location poster on east face. It states "Approx. 1/4 corner"

There is some evidence that there has been a large p. pine in the approx. location of the S.W. B.T. All old growth timber in SE quadrant has been cut. No stump in approx. location of SE B.T. No reliable evidence available.
