# T1S R33E

## SECTION 1 THROUGH SECTION 6

A PORTION OF THE BOUNDARY OF THE DIMINISHED  
UMATILLA INDIAN RESERVATION

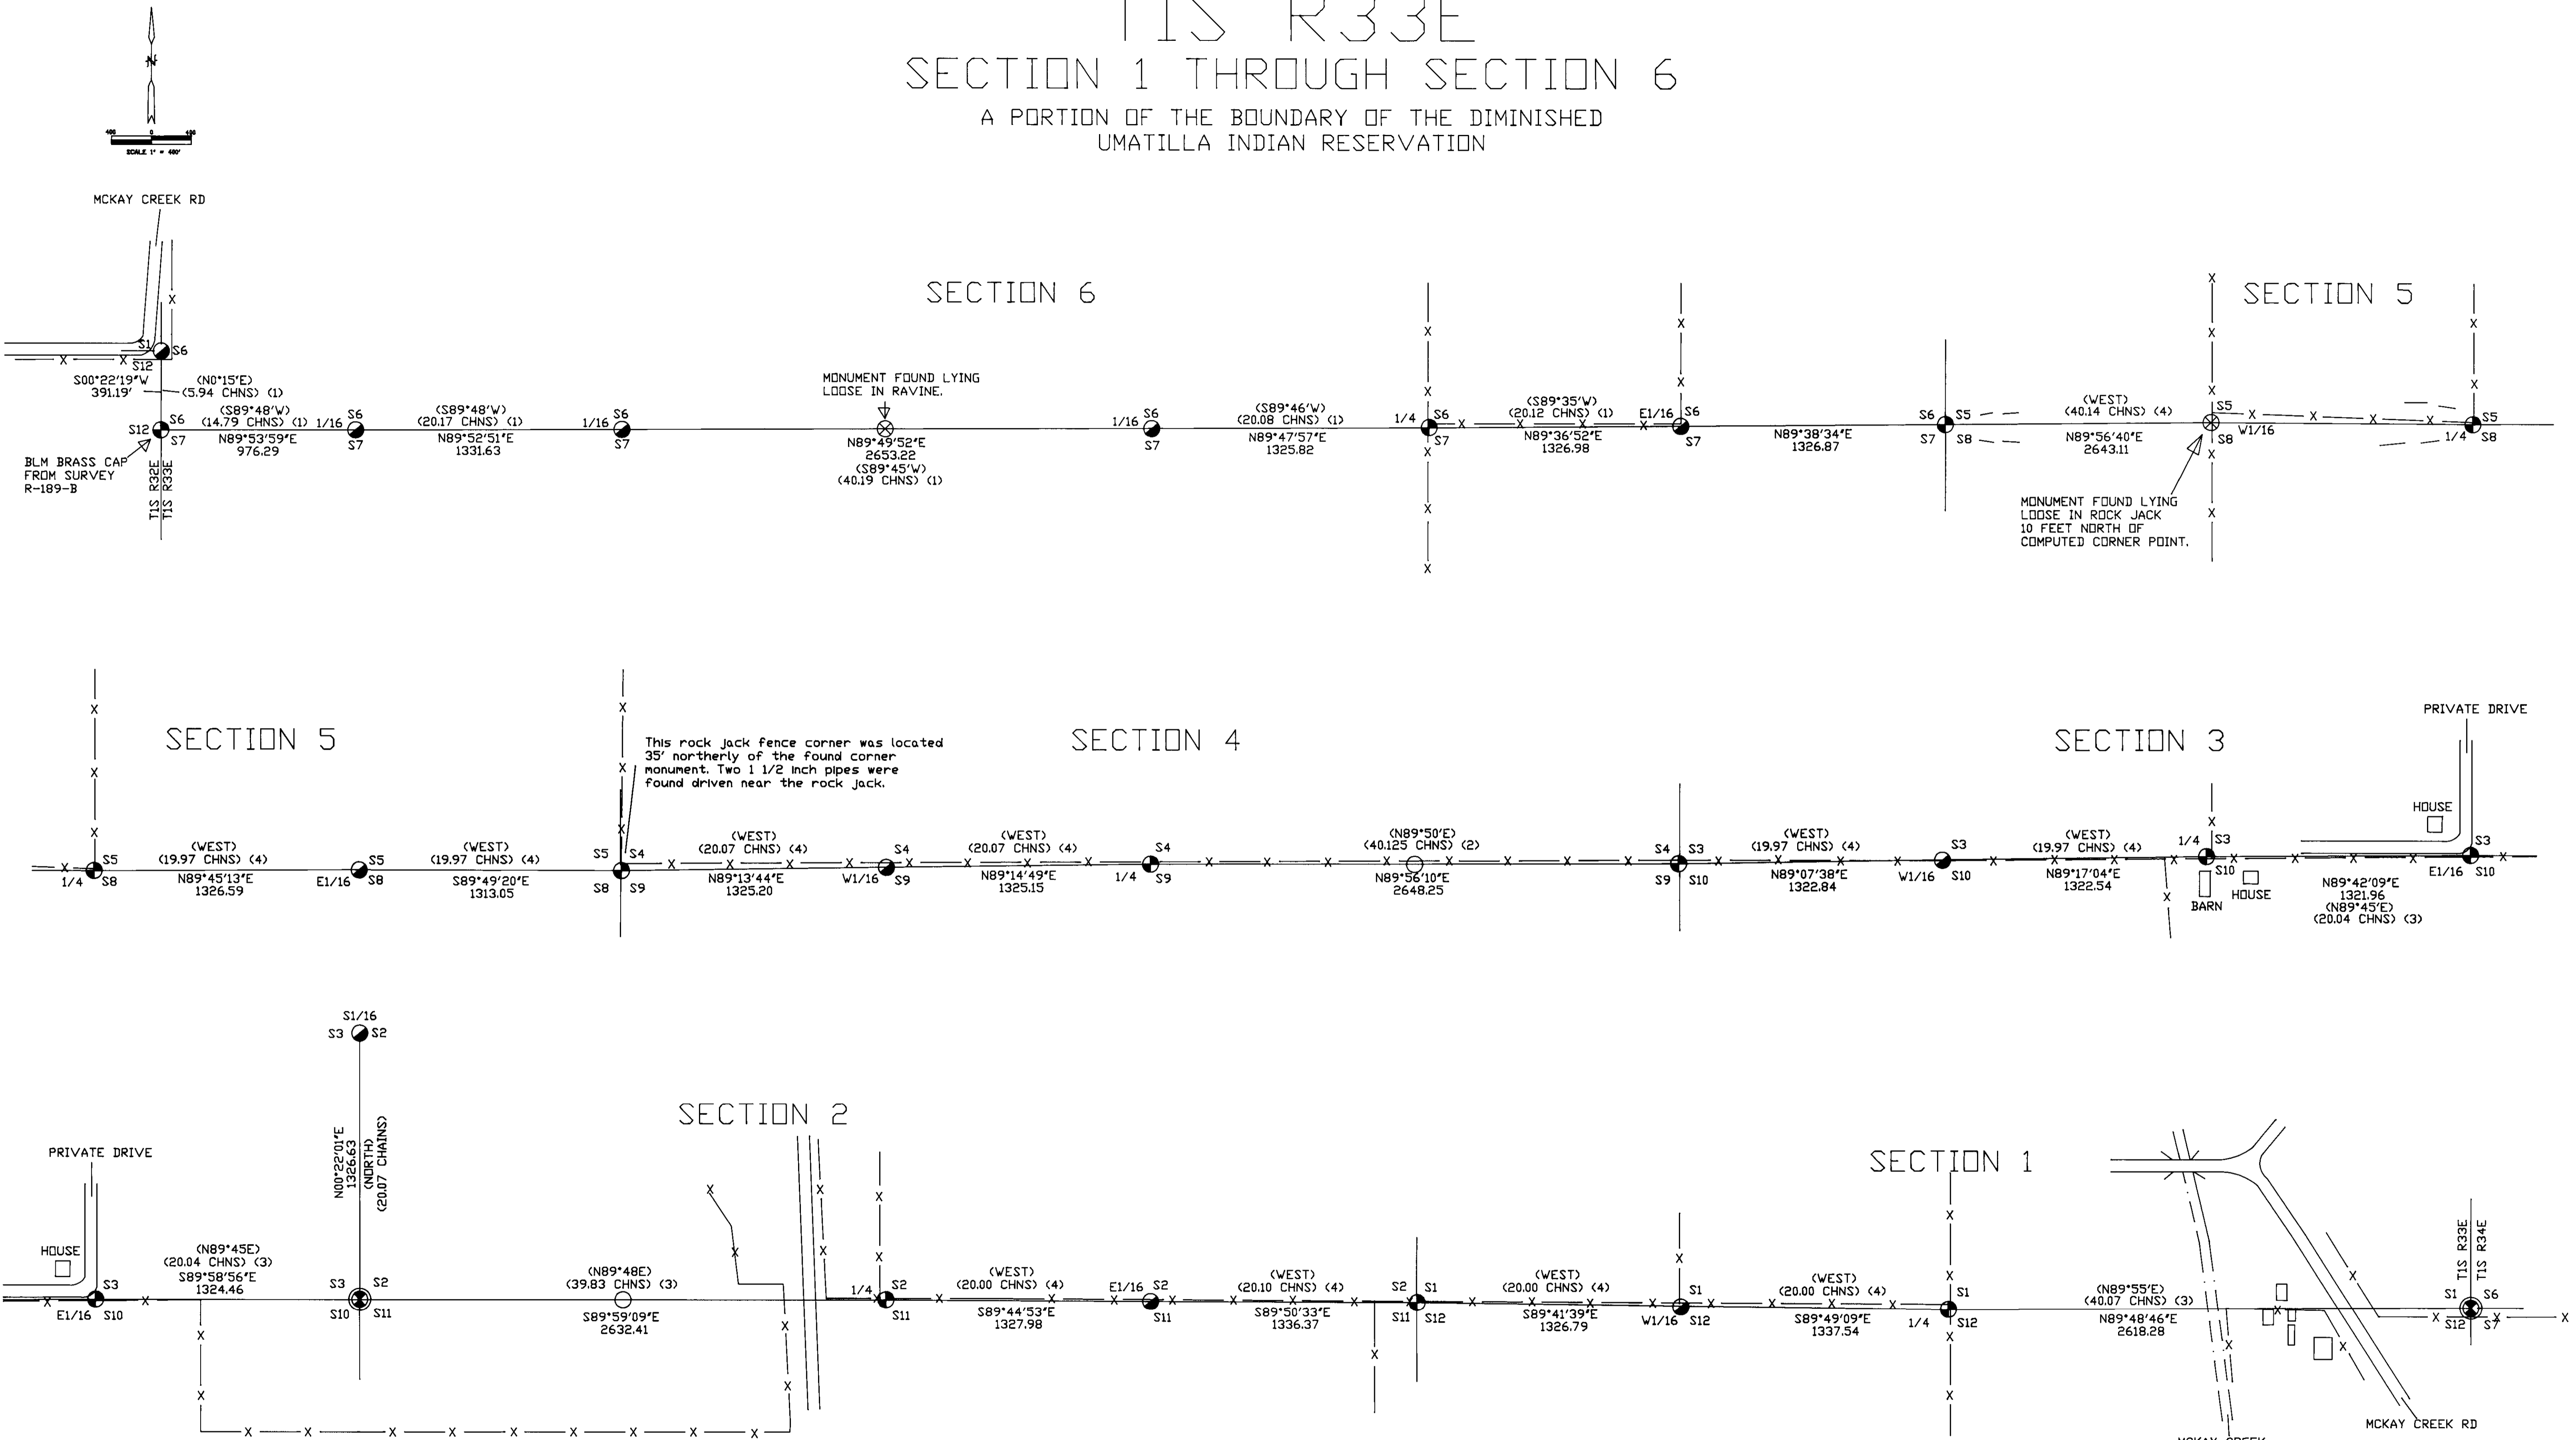
**BASIS OF BEARINGS:**  
Bearings are based on local grid coordinates rotated to true around the corner to sections 1, 12, and 6. Bearings were rotated 1°17'14\"/>

**NOTE:**  
This survey was performed with a Wild System 200 GPS and a Geodimeter System 600 Electronic Total Station.

This survey was performed at the request of WORLDCOM NETWORK SERVICES INC. The purpose of the survey was to identify a portion of the Umatilla Indian Reservation Boundary preparatory to laying a fibre optic communications line.

The reference surveys used are listed in the legend on this plat. All monuments established by the reference surveys have been in location for sufficient duration to accurately represent the Reservation Boundary. Lines were established from monument to monument.

The section corner to sections 2, 3, 10, and 11 was missing and was replaced using the modified method of single proportion for a boundary previously proved irregular by retracement as outlined in section 5-36 of the 1973 BLM manual. The corner to sections 1, 12, 6, and 7 was missing and was replaced from the witness stump for that corner.
