NARRATIVE OF SURVEY

SURVEY FOR
RANDY AND COLLEEN SLY
 72357 KORVOLA RD.
 PENDLETON, OR. 97801

NW 1/4, S21
 T2N, R32E, W.M.
 UMATILLA COUNTY
 OREGON

PROJECT No. 99-10
 SURVEY DATE: 4-28-99

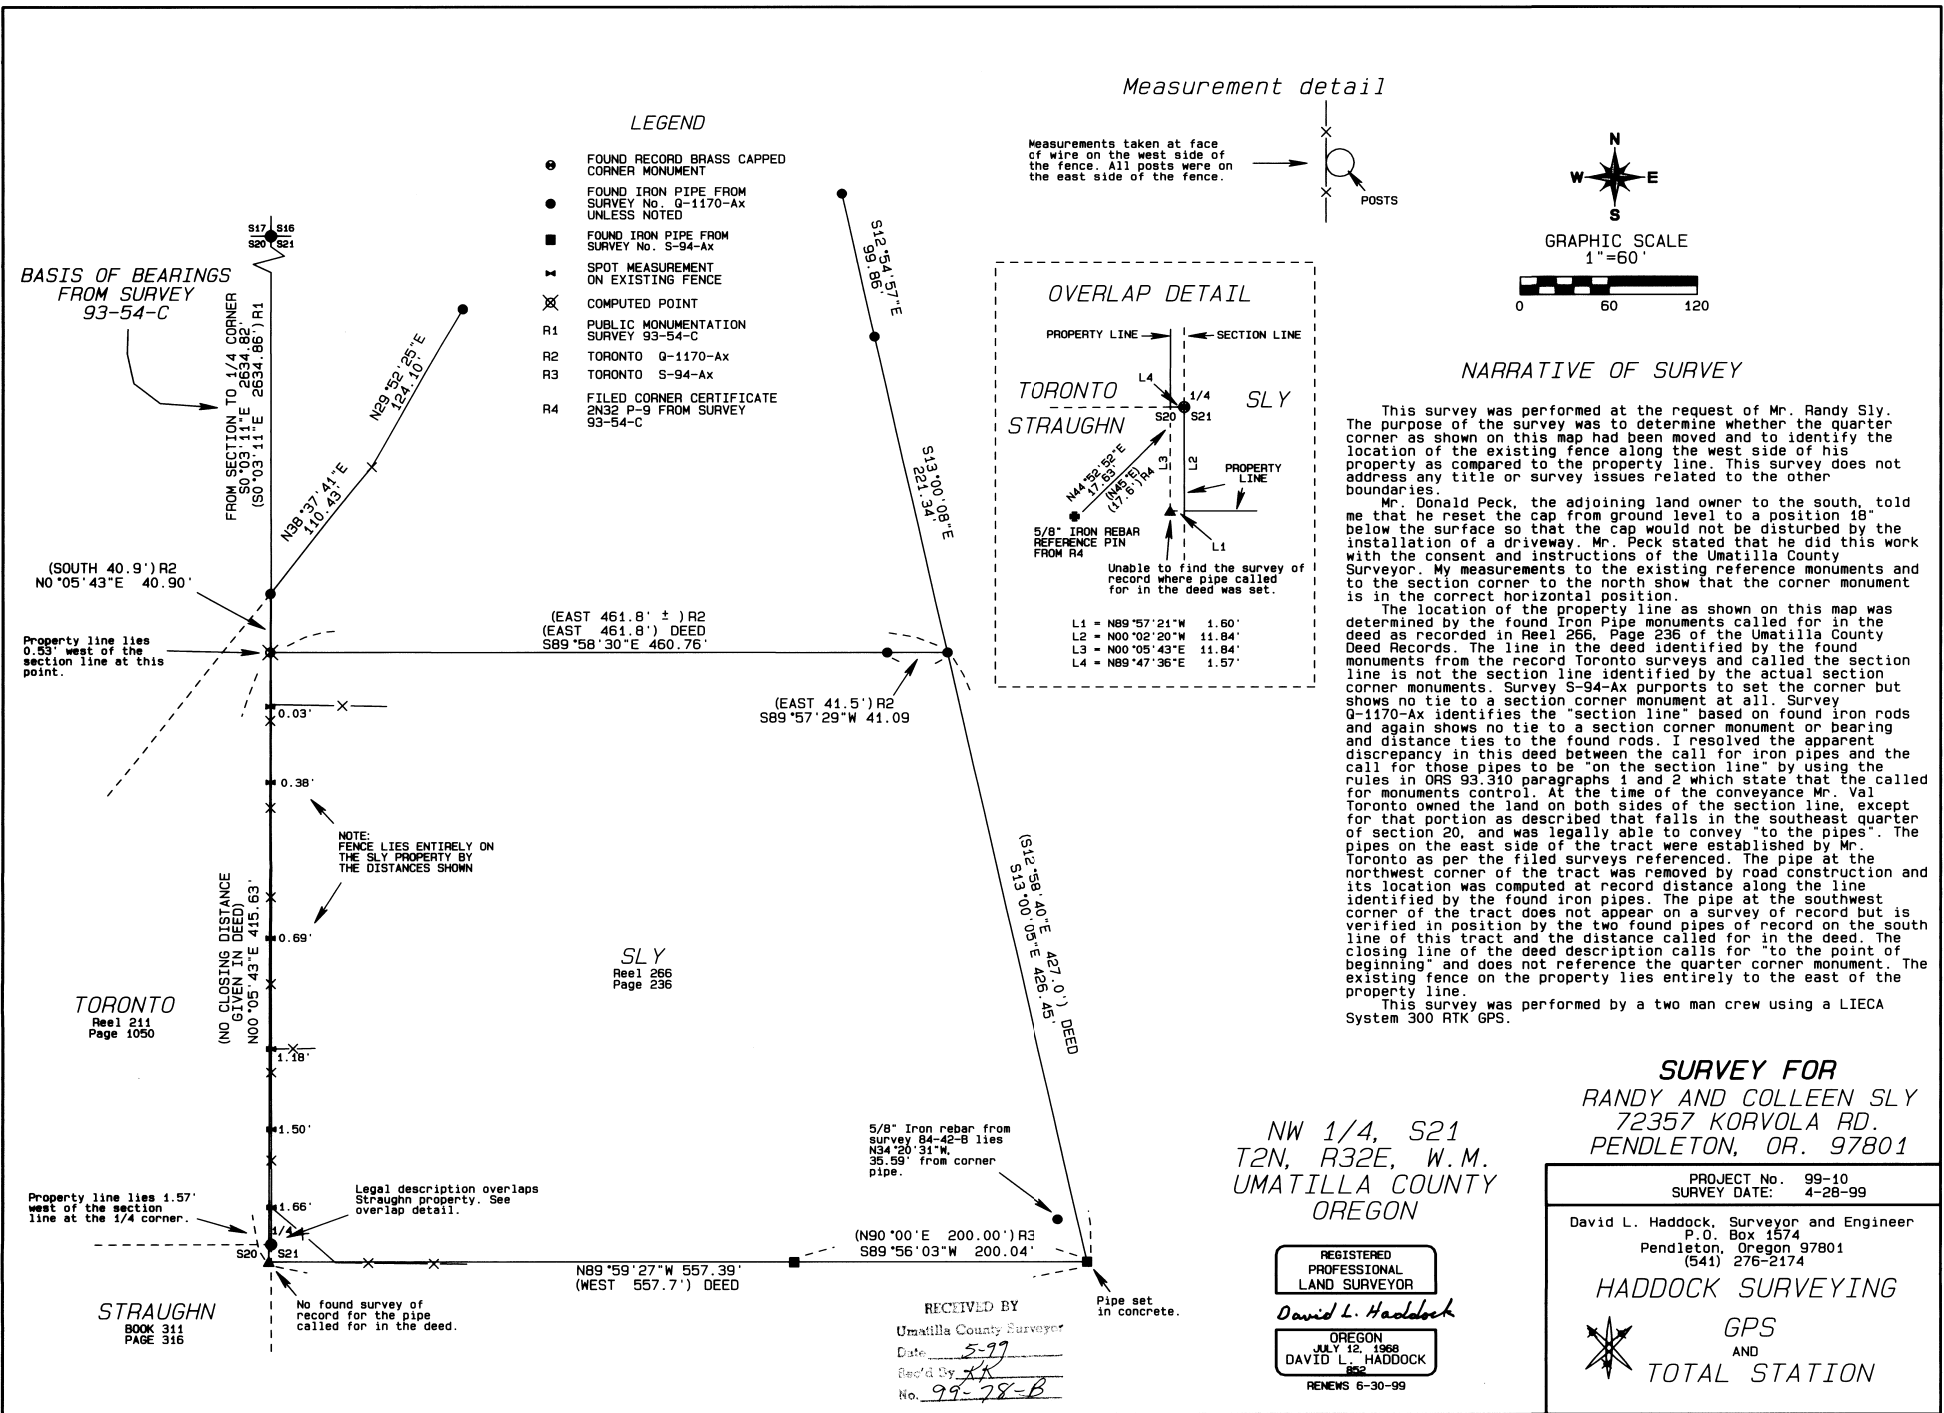
This survey was performed at the request of Mr. Randy Sly. The purpose of the survey was to determine whether the quarter corner as shown on this map had been moved and to identify the location of the existing fence along the west side of his property as compared to the property line. This survey does not address any title or survey issues related to the other boundaries.

Mr. Donald Peck, the adjoining land owner to the south, told me that he reset the cap from ground level to a position 18" below the surface so that the cap would not be disturbed by the installation of a driveway. Mr. Peck stated that he did this work with the consent and instructions of the Umatilla County Surveyor. My measurements to the existing reference monuments and to the section corner to the north show that the corner monument is in the correct horizontal position.

The location of the property line as shown on this map was determined by the found Iron Pipe monuments called for in the deed as recorded in Reel 266, Page 236 of the Umatilla County Deed Records. The line in the deed identified by the found monuments from the record Toronto surveys and called the section line is not the section line identified by the actual section corner monuments. Survey S-94-Ax purports to set the corner but shows no tie to a section corner monument at all. Survey Q-1170-Ax identifies the "section line" based on found iron rods and again shows no tie to a section corner monument or bearing and distance ties to the found rods. I resolved the apparent discrepancy in this deed between the call for iron pipes and the call for those pipes to be "on the section line" by using the rules in ORS 93.310 paragraphs 1 and 2 which state that the called for monuments control. At the time of the conveyance Mr. Val Toronto owned the land on both sides of the section line, except for that portion as described that falls in the southeast quarter of section 20, and was legally able to convey "to the pipes". The pipes on the east side of the tract were established by Mr. Toronto as per the filed surveys referenced. The pipe at the northwest corner of the tract was removed by road construction and its location was computed at record distance along the line identified by the found iron pipes. The pipe at the southwest corner of the tract does not appear on a survey of record but is verified in position by the two found pipes of record on the south line of this tract and the distance called for in the deed. The closing line of the deed description calls for "to the point of beginning" and does not reference the quarter corner monument. The existing fence on the property lies entirely to the east of the property line.

This survey was performed by a two man crew using a LIECA System 300 RTK GPS.

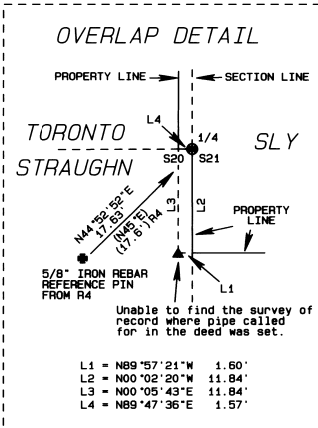
Measurement detail

- L1 = N89°57'21"W 1.60'
- L2 = N00°02'20"W 11.84'
- L3 = N00°05'43"E 11.84'
- L4 = N89°47'36"E 1.57'
