Narrative: This survey at the request of State Farm Ins. was made to locate the common line of Block 178 and the Lot line between lots 1&2, Reservation Add., Pendleton, Ore. S.W.1/4, N.W.1/4, Sec.11, T.2N. R.32E. W.M., Umatilla County, Ore.

Lot line locate for State Farm Ins. Lot Line/ Lots 1&2, and common line. Of Block 178 Reservation, Add.

97-198-A

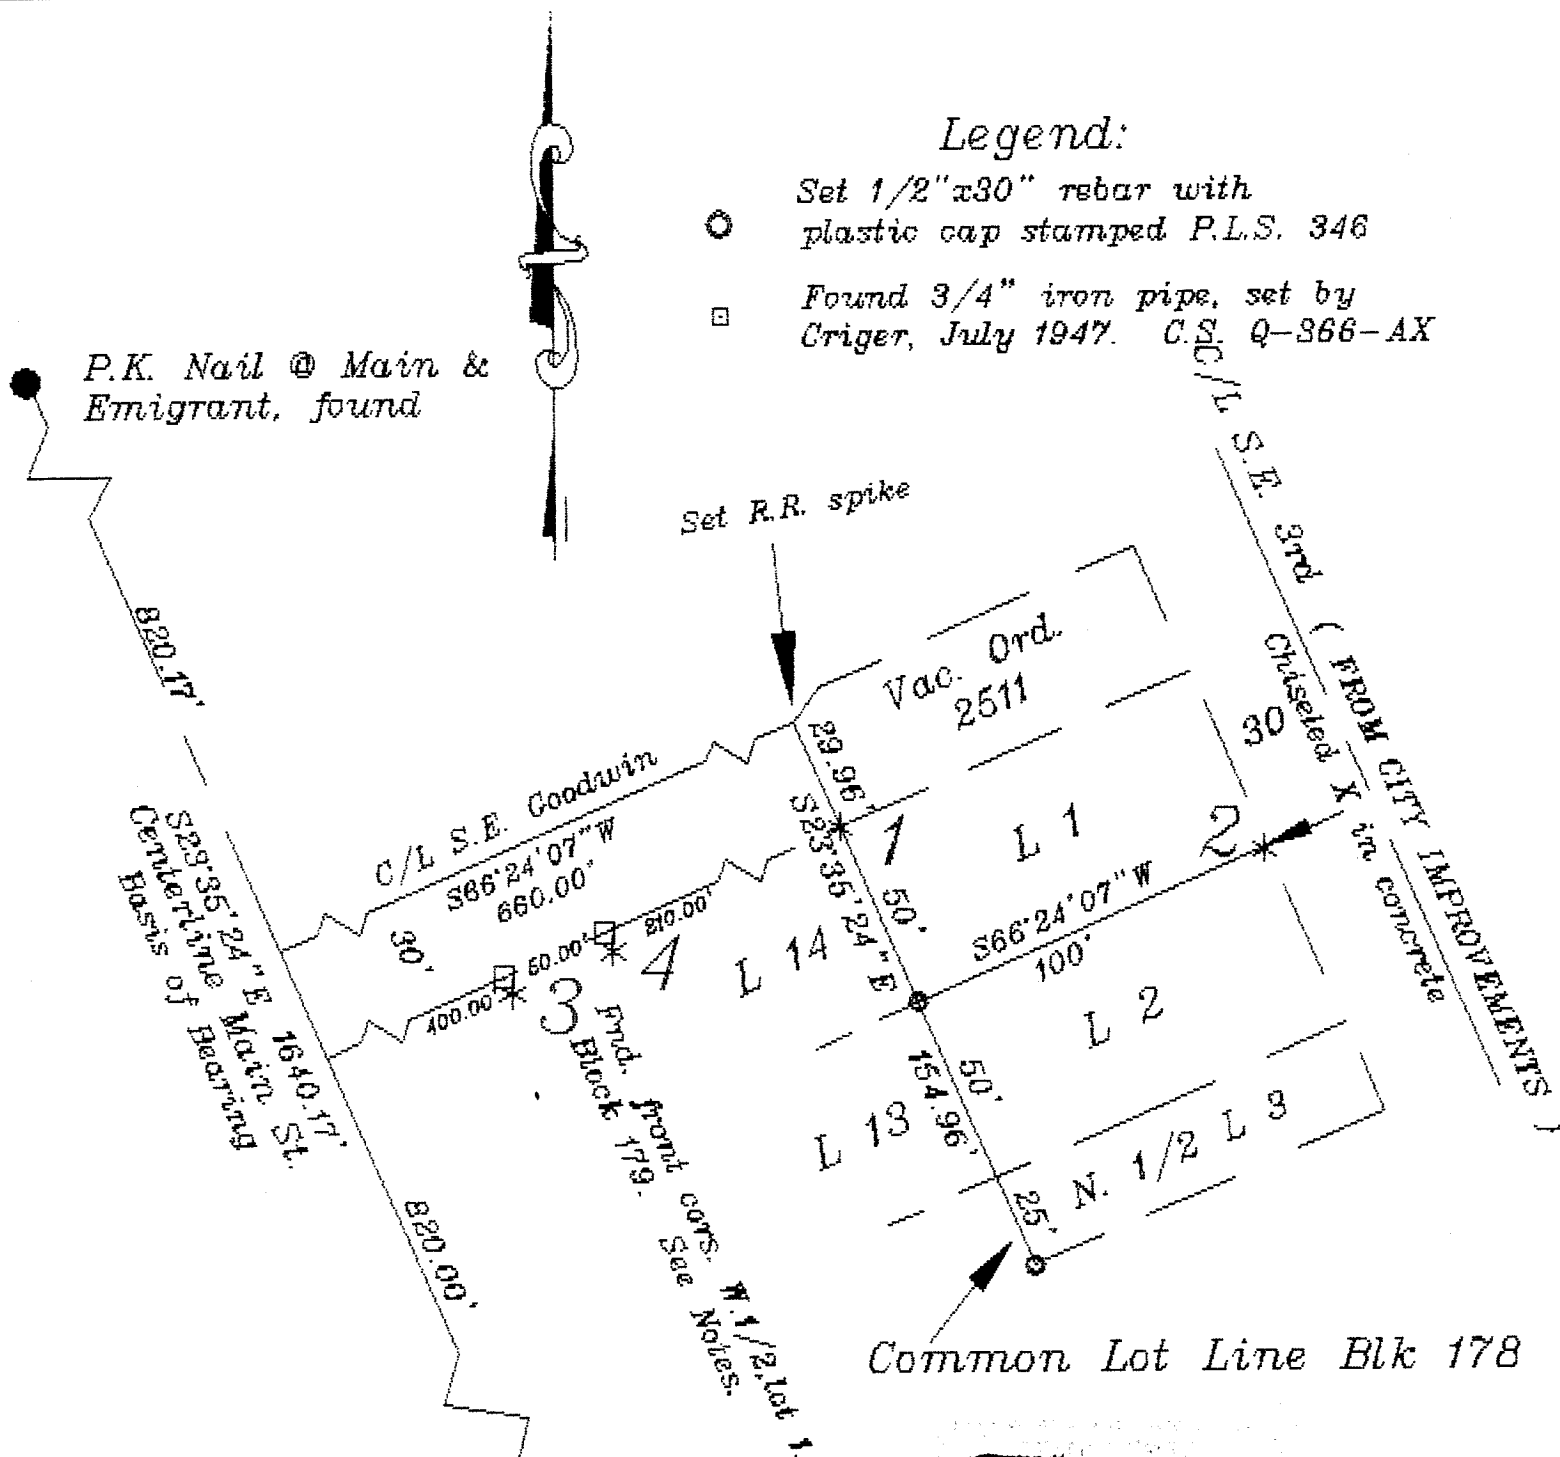
I occupied the B.C. at Issac and Main streets with the P.K. at Main and Emigrant as the B.S. I traversed into the work area. I held the record R.O.W.s blk. dimensions, and bearing of Main St. I did split the bearings of Emigrant and Issac aves. to determine the centerline bearing of S.E. Goodwin. The chiseled X at the N. corner of Lot 2 falls at the back of sidewalk of S.E. 3rd St. Back of walk to back of walk S.E. 3rd st. is 60ft.

- Notes: Broken lot lines are unsurveyed.
- *1- Lot 1's, 1' x 8' x 16' rock wall encroaches onto Lot 14. One foot at the front and three feet at the end of 16'.
 - *2- Lot 2's bottom conc. step encroaches as a pis, 3' x 5.5' onto lot 1
 - *3- Fnd. 3/4" I. pipe front lot cor. of Lot 14, Blk. 179, bears S10°13'32"W, 0.65' from calc.
 - *4- FND. 3/4" I. pipe, front lot cor. of Lot 1, Blk. 179, bears N75°35'42"W, 0.33' from calc.

P.K. Nail @ Main & Emigrant, found

Centerline Bearing
S23°35'24" E Main St.
1640.17'

City 3 1/2" B.C. Main St. & Issac Ave.
