CORNER RECORD (SEARCH)
 (Ref. FSM 7151.4)

Tract or Survey No. _____ Cor. No. _____
 R.D. Ukiah County Umatilla
 N.F. Umatilla State Oregon

CORNER RECORD (PERPETUATION)

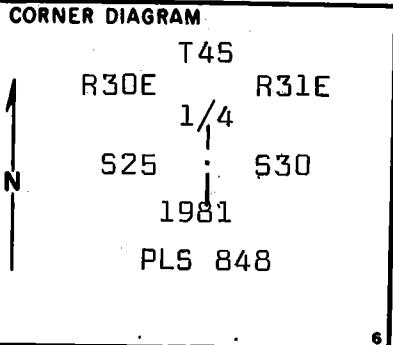
Corner has been destroyed by fence construction.

No bearing trees previously established. Positioned corner by proportion from found corners 1/2 mile North and 1/2 mile South.

Corner is on NE side of gentle open SE draw, approx. 250 ft. from draw bottom Ridge road approx. 250 ft. North from corner. Corner is visible from road.

Set 3"x30" galv. iron pipe with 3" brass cap stamped as shown on the diagram; set 10 inches in the ground and raised a mound of stone around the pipe.

No bearing trees available.
Set steel posts with warning and boundary signs 7.0 ft. North and 6.2 ft. West from corner.
