HISTORY OF ORIGINAL CORNER ESTABLISHMENT:

The source of the monumentation and dimensions cited in this record is a Dependent Resurvey of ...Portions of the South and East Boundary, and Subdivisional Lines of Township 6 North, Range 38 East, Willamette Meridian, conducted by the Bureau of Land Management, commenced on October 13, 1987, and completed September 16, 1991.

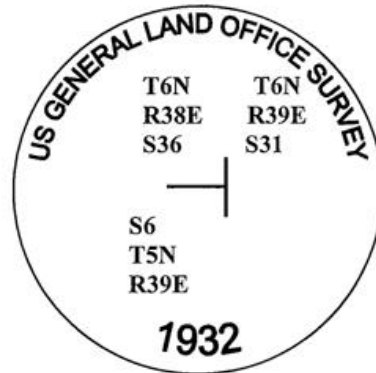
DIAGRAM

The SE corner of T6N, R38E, monumented with an iron post, 3 ins. diam., firmly set, protruding 8 ins. above the ground, with brass cap mkd: (see Diagram below)

A 3 1/2" dia. Brass cap on a 3" dia. Iron pipe, marked as shown, firmly set, extending 8" above ground, from which:
