OREGON CORNER RESTORATION FORM

Section: 25 & 26
Township: 6 North
Range: 35 East of the Willamette Meridian
County: Umatilla
Date: June 28, 2002

Corner Indexing Information: Township 6N Range 35E Corner Code T 21 (Willamette Meridian)

This quarter corner is common to sections 25 & 26.

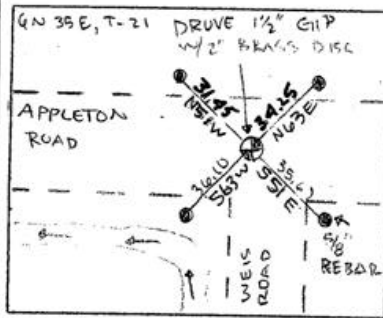
Monument Detail:

Drove ¾" rebar to 3" deep. Drove 1 ½" x 15 ½" galvanized iron pipe around ¾" rebar and placed 10" of concrete around pipe and filled with concrete and set 2" brass disc on top of the pipe at ½" below surface pavement stamped (see example below)
