T 6S R. 30E

CORNER RECORD (SEARCH)

R.D. UKIAH County UMATILLA

N.F. UMATILLA State OREGON

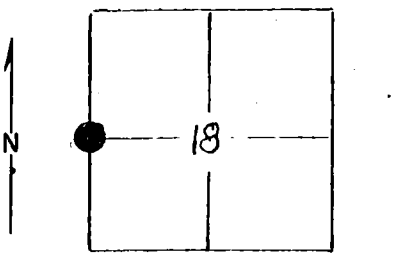
CORNER DIAGRAM

None
Monumented

A 16" ponderosa pine in good vigor and condition bearing S22°E 49 lks has a good pair of scars indicating ¼S and bt markings. Painted a 6" band around it plus painted scars. Attached proper tags, put two steel posts up about 3' from approx. corner location and attached two metal signs to each, indicating a corner in property. There was already a bt tag on tree, put there by BLM.
