USDA-FOREST SERVICE

CORNER RECORD (SEARCH)

T 6 S. R. 34 E.

R.D. NORTH FORK JOHN DAY County UMATILLA

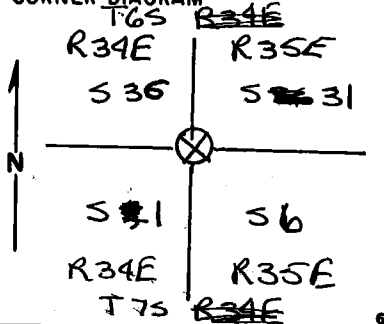
CORNER DIAGRAM

None found.

10" Lodgepole pine with scribing "56" on NW face is now down at top of highway embankment and has 2 k-tags on it.

Located about 50ft east of enter and leave signs on highway. (Rd. 52)
