RECORD OF SURVEY
 within the SE1/4 SE1/4 Section 9,
 Township 4 N., Range 28 E., W.M.,
 Umatilla County, Oregon

SURVEYOR'S NARRATIVE & CERTIFICATE

SURVEY FOR
AL POGUE
CK3, LLC
 CIVIL-STRUCTURAL-ELECTRICAL ENGINEERING,
 SURVEYING & PLANNING

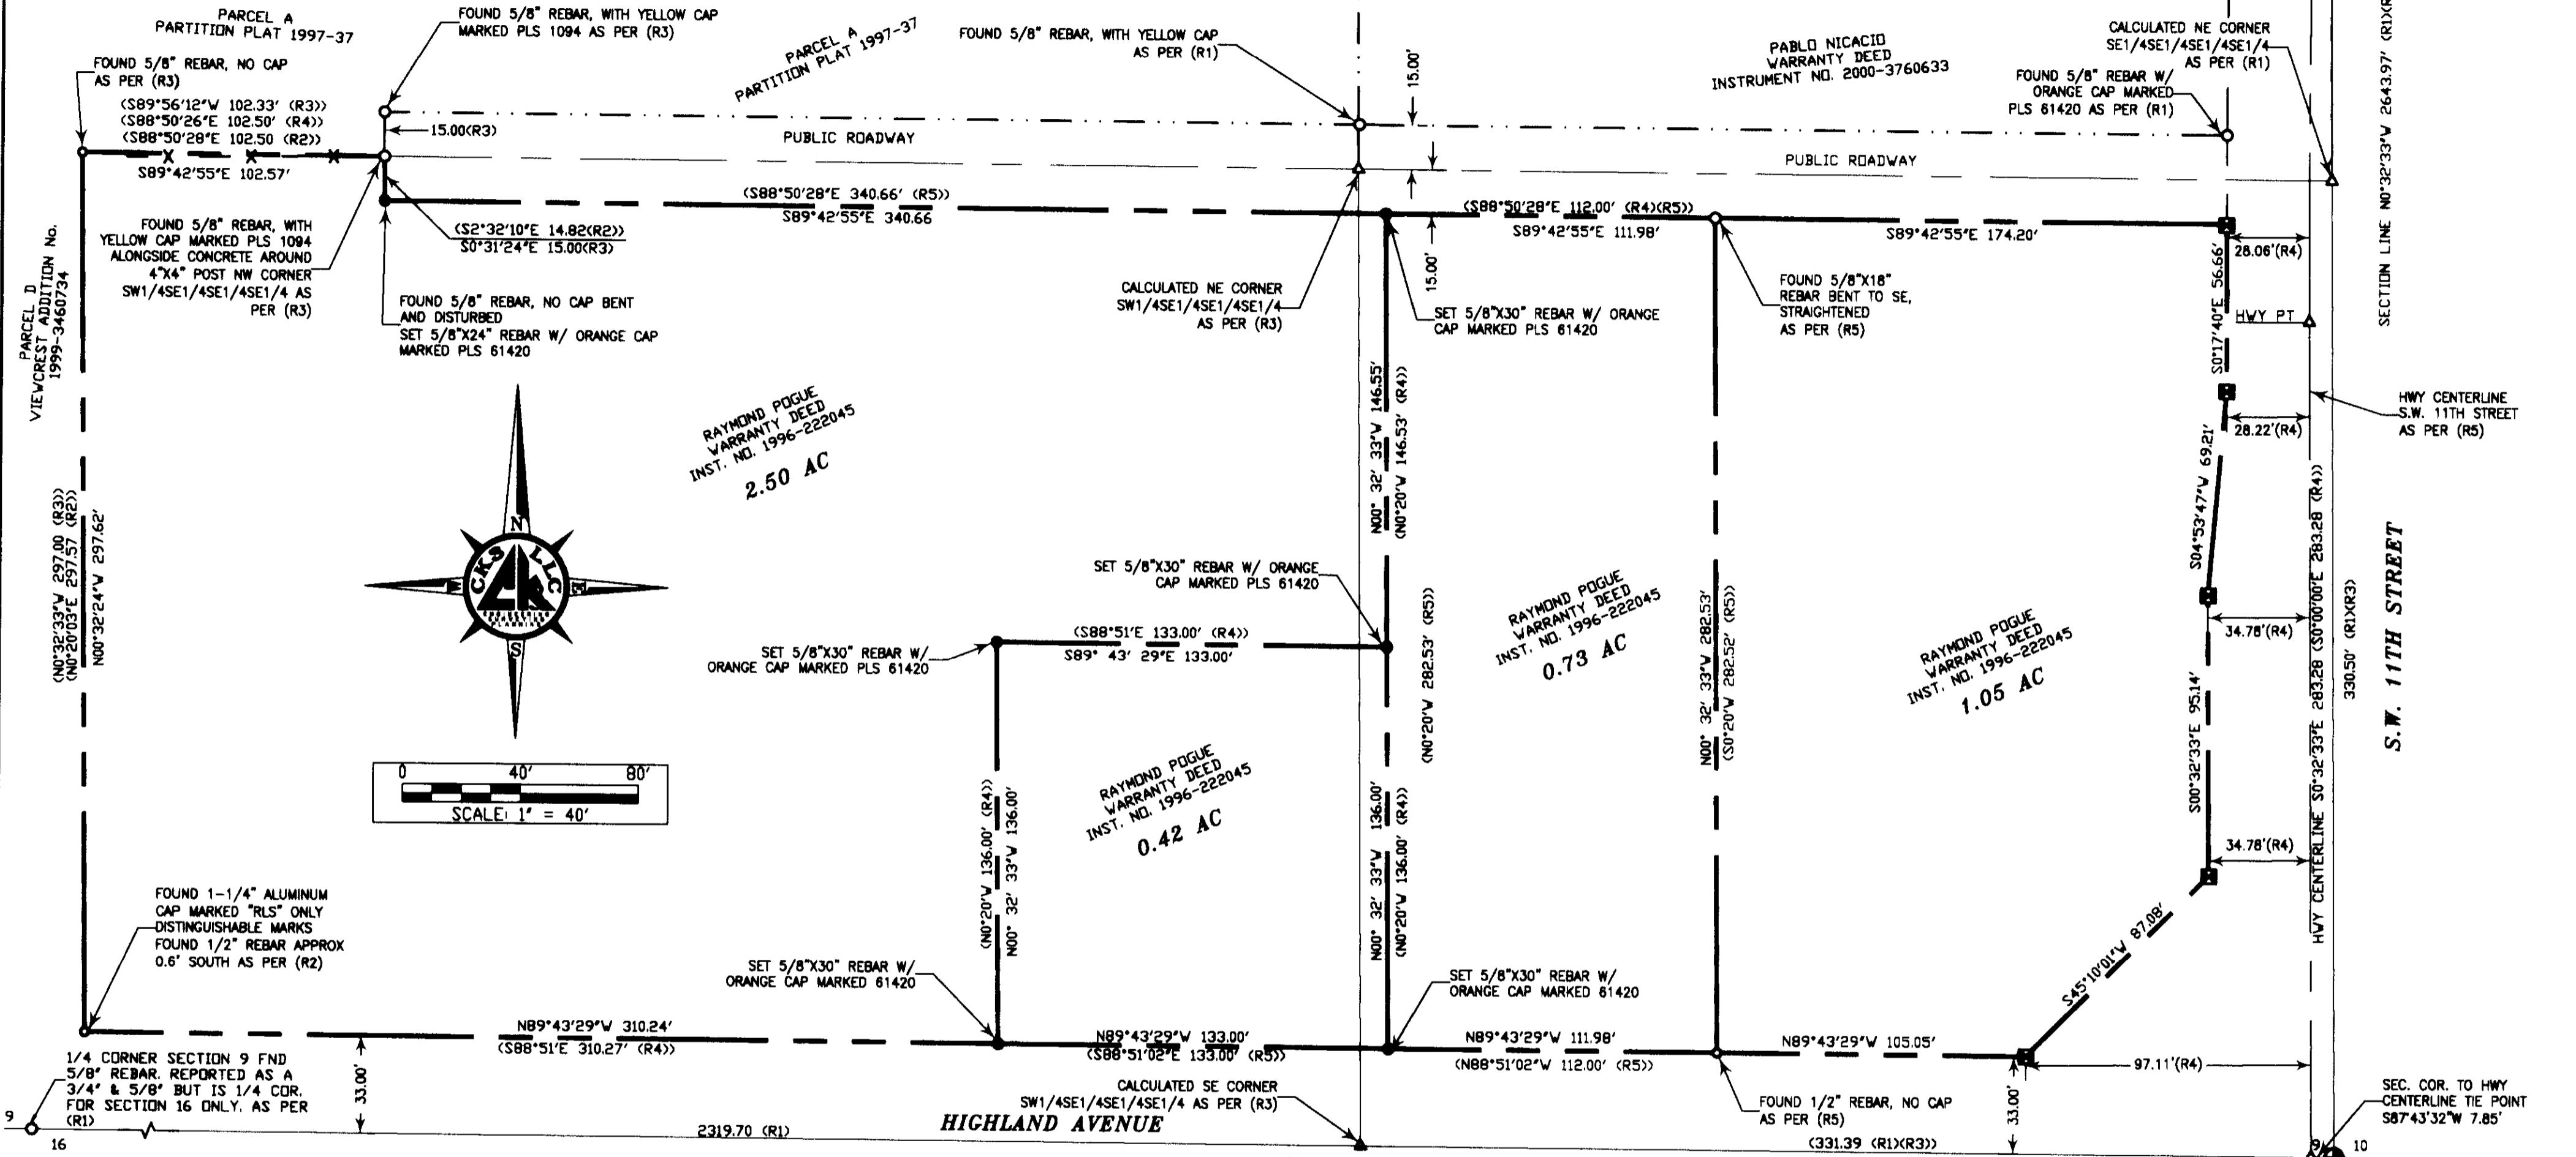
THIS SURVEY WAS MADE AT THE REQUEST OF AL POGUE FOR THE PURPOSE OF RETRACING THE EXISTING BOUNDARY OF A PARCEL OF LAND AS DESCRIBED IN STATUTORY WARRANTY DEED INST. NO. 222045. CONTROL FOR THIS SURVEY IS FROM FOUND MONUMENTS AS SHOWN ON THIS MAP. THE BASIS OF BEARING FOR THIS SURVEY IS ALONG THE SOUTH LINE OF SECTION 9 AS SHOWN ON THIS SURVEY AND OF RECORD (R1) AS SHOWN ON THE REFERENCE TABLE HEREBON.

A PORTION OF THE NORTH LINE, EAST LINE AND SOUTH LINE OF THE OVERALL BOUNDARY WAS RETRACED ALONG EXISTING WELL ESTABLISHED AND SURVEYED RIGHT-OF-WAYS. THE WEST LINE AND REMAINDER OF THE NORTH LINE WAS RETRACED FOLLOWING (R2), (R3) AND REFERENCING (R4) I FOUND EXISTING MONUMENTS AS SHOWN. THERE IS A FENCE LINE ALONG A SHORT PORTION OF THE NORTH BOUNDARY LINE AS SHOWN AND AGREES WITH SURVEY MONUMENTS. THE REMAINDER OF THE EXTERIOR BOUNDARY HAS NO VISIBLE USAGE LINES.

THE INTERIOR BOUNDARY LINES OF THE FOUR PARCELS WERE RETRACED USING DEED CALLS. THE INTERIOR MONUMENTS FOR THESE PARCELS WERE SEARCHED FOR AND FOUND AS NOTED PER (R5). THIS SITE HAS BEEN GRADED AND CLEARED SOME TIME IN THE PAST AND MANY OF THE EXISTING MONUMENTS HAVE BEEN REMOVED. I RE-ESTABLISH THE MISSING MONUMENTS BASED ON SECTION CONTROL AND DEED CALLS. THERE ARE NO VISIBLE USAGE LINES.

THE ADJOINING DEEDS OF RECORD AS SHOWN ON THIS MAP WERE CHECKED FOR OVERLAPS AND GAPS AND I FIND NO PROBLEM WITH THE WRITTEN DEED DESCRIPTIONS.
