U. S. Department of Agriculture
FOREST SERVICE

Umatilla NATIONAL FOREST

CORNERS OF THE PUBLIC SURVEY

Corner common to Sections
9, 10, 15 and 16

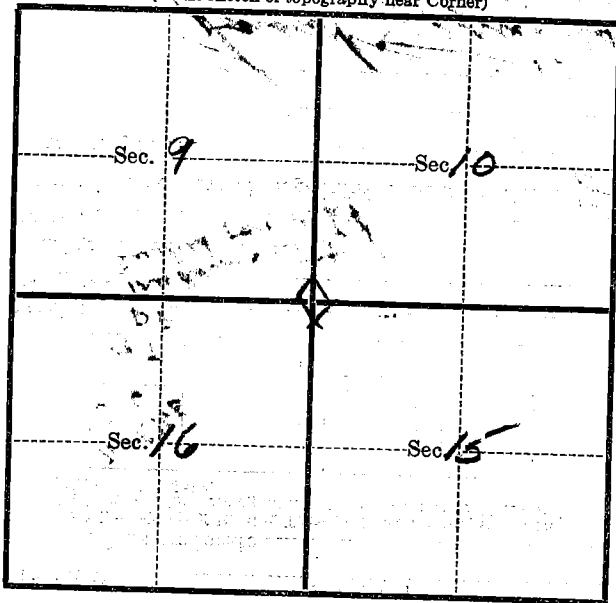
T. 1N R. 36E W. Mer.
(Make sketch of topography near Corner)

Metal Location Poster is on a 2" DF
tree 2" inches diameter, on the
side of _____
from which this Corner bears _____
_____ chains distant.

1/2 dis above draw
Diagram plate - 9-59
