CORNER RESTORATION FORM

Township 3N Range 28E Section 6 County UMATILLA

State OREGON Date 12/21/12 Number E3

Corner Designation : SOUTH 1/4

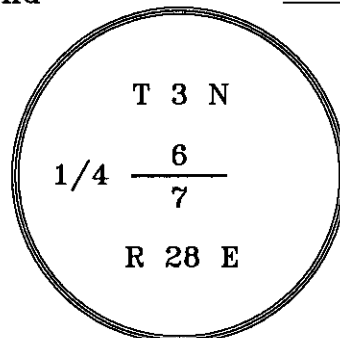
MONUMENT DETAIL

FOUND 3/4 INCH (SMOOTH) IRON ROD

NO RECORD OF THIS MONUMENT COULD BE FOUND

BUT APPEARS TO HAVE BEEN ACCEPTED IN THE

PAST AND I THEREFOR HELD IT POSITION.

DETAIL FOR REFERENCE ONLY,

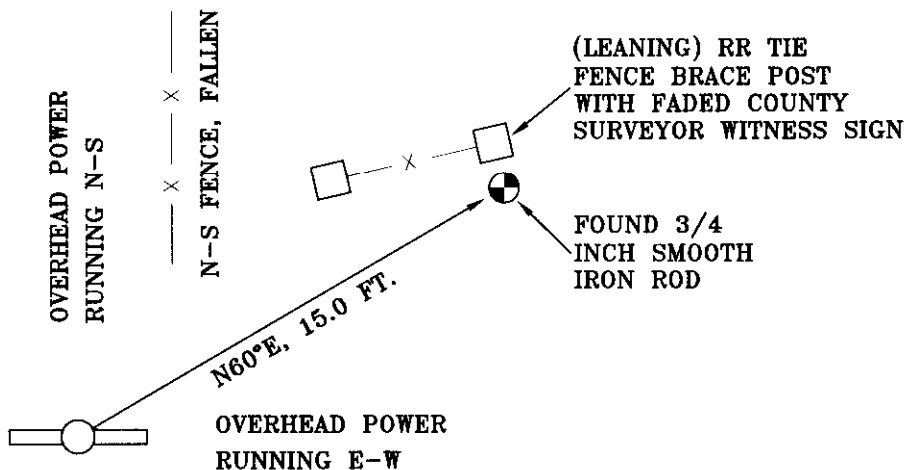
Sketch of Monument, Accessories and General Area

A FADED UMATILLA COUNTY SURVEYOR WITNESS POST SIGN ON A LEANING RAILROAD TIE FENCE BRACE POST 0.5 FT. NORTH OF MONUMENT.

SEARCH AREA IS NEAR SOUTHERLY MOST POLE OF LARGE N-S OVERHEAD POWERLINE

MONUMENT LIES N60°E, 15.0 FT. FROM FACE OF SOUTHERLY MOST POWER POLE
