OREGON CORNER RESTORATION FORM

Section 5 Township 31N Range 29E
 County Umatilla Date 07-08-02
 Corner Designation 3N28R3

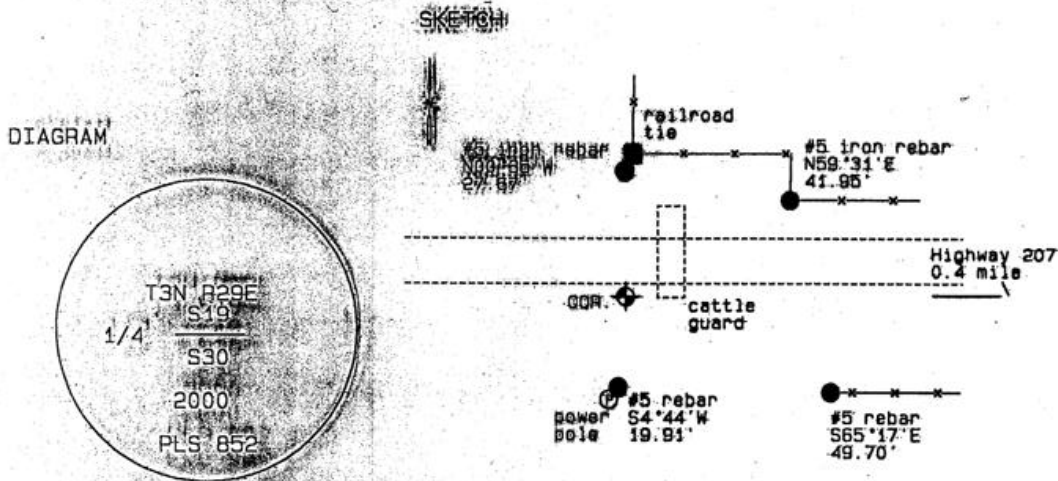
Set a punched railroad spike in place of a PK nail set in survey 91-61-B. Also found a brass capped witness corner set by survey S-158-C.

Found the record monument above.
