CORNER RESTORATION FORM

Township 3N Range 30E Section 19 & 20 County UMATILLA

Corner Designation : 1/4 SECTION 19 & 20

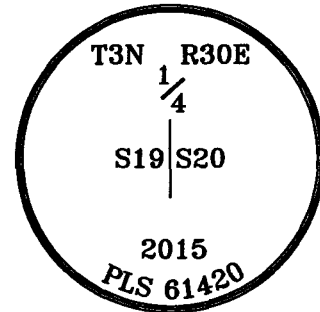
MONUMENT DETAIL

- SET 2 1/2" BRASS CAP ON 1 1/4"x16" PIPE 0.7 BELOW GRADE IN ROAD DRIVEN IN HARD PAN.
- SET 5/8" REBAR & CAP PLS 61420 AT GRADE ON ROAD BANK, N79°30'E 45.39'.
- SET 5/8" REBAR & CAP PLS 61420 AT GRADE NW CORNER TIN ROOF WILDLIFE WATERER, S35°47'E 78.53'.
- SET 5/8" REBAR & CAP PLS 61420 AT GRADE, SET BEARING OBJECT SIGN ON GREEN STEEL POST, S43°46'W 26.10'.
- SET 5/8" REBAR & CAP PLS 61420 AT GRADE, N72°03'W 27.70'.
