# OREGON CORNER RESTORATION FORM

Section 30 Township 3N Range 35E  
 County Umatilla Date: 09-02-2004

Corner Designation: 3N35EV1

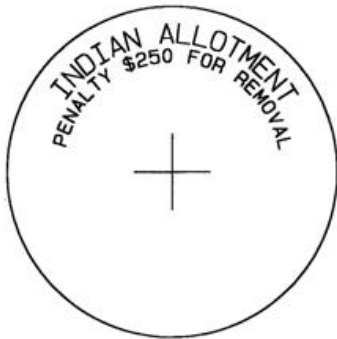
DIAGRAM

Found 3.25" dia. brass cap un-stamped as shown in the diagram below, and in the attached photographs. The brass cap was located at the intersection of Duff Road (County Road # 794) and Pambrun Road (County Road # 737). The cap was 4 inches below the road surface, and is without any section stampings (see attached photographs).
