**OREGON CORNER RESTORATION FORM**

Section 29 Township 3N Range 35E  
 County Umatilla Date: 09-02-2004

Corner Designation: 3N35E5 \_\_\_\_\_ x \_\_\_\_\_ Condition Report Only  
 \_\_\_\_\_ Not Found  
 \_\_\_\_\_ Remonumented  
 \_\_\_\_\_ Unrecorded  
 \_\_\_\_\_ Surveyed In  
 \_\_\_\_\_ Referenced Out

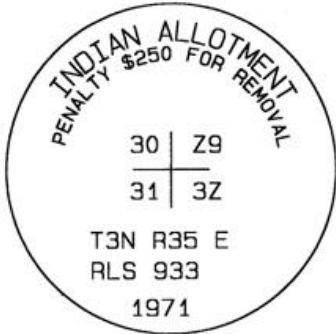
**DIAGRAM**

Found 3.25" dia. brass cap stamped as shown in the diagram below, and in the attached photographs. Brass cap was located on Duff Road (Umatilla County Road # 794) approximately 1.5" below the county road surface, and 27 feet east of a southernly field access road and 8 feet North of chiseled rocks as shown in the attached photographs.
