OR. ON PUBLIC LAND CORNER REPORT / RESTORATION REPO...
 Umatilla County Surveyor's Office

SECTION 19	TOWNSHIP 3N	RANGE 36E
COUNTY: Umatilla		DATE 6/20/08
CORNER DESIGNATION: O-6 Northwest 1/16 corner of Section 20		(Please check one) <input type="checkbox"/> Condition Report Only <input type="checkbox"/> Not Found <input type="checkbox"/> Renewed <input type="checkbox"/> Unrecorded <input checked="" type="checkbox"/> Surveyed In <input type="checkbox"/> Referenced Out
Previous Renewals / Surveys, etc. This corner was originally set by U.S. Indian Services Surveyor C.E. Redfield in 1919		
Monument(s) & Accessories Found: (Condition & Source) None found this area has been farmed		
Monument Detail:

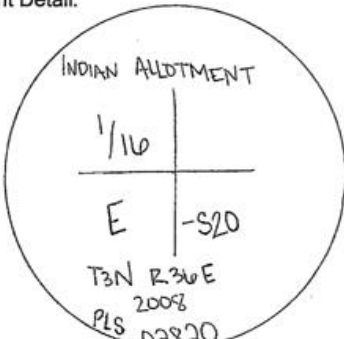
Monument Set (Procedures and Description): at the surveyed position on the prolongation of a line from the found 1/16 corner on the East line of Section 20 through the found center North 1/16 corner of Section 20 set a 1/2"x30" galvanized iron pipe with a 2" brass cap 18 inches in the ground 1.2 feet east of a North-South fence.

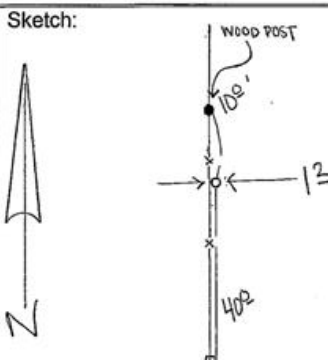
Sketch:

New Accessories: Placed a bearing tree sign on a wood fence post 10 feet North of the corner and on a Railroad Tie fence post 40 feet south of the corner.		
Location & Comments: The corner is located on a grassy, open, gentle south slope 1.2 feet east of a North-South Fence		Compass Declination: 19° East
Firm / Agency USKH Inc. Address: 5 N. Colville St. Walla Walla, WA 99362 Party Chief Damon Locke		SURVEYOR'S SEAL
