LAND CORNER RECORD

1. T3N R 37E No. N 9 Cor. Sec. Mer. Will State Oregon (Rectangular) N. F. Umatilla Dist. Pendleton

1. T. 3N R. 37E No. 16 Cor. 16 Sec. Mer. W State Oregon (Rectangular) N. F. Umatilla Dist. Pend 23

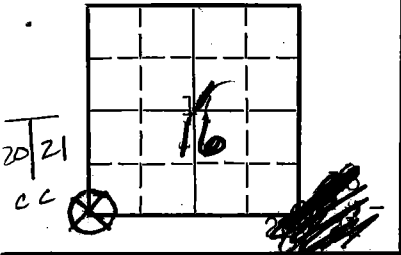
7. Photo Identification
Photo No. UM 32b-3
Ident. By:

4. Description of Corners: Found, at corner of sec. 16 & 17, a Basalt Stone 16 x 12 x 7 inches on N.W. face of spur, marked and witnessed as described by surveyor - general. At the point of intersection, (89 links N 89° 45' E from sec 16 & 17 corner) I set a basalt stone 12x12x5 inches, 8 inches in the ground for (see remarks)

5. Investigation Notes: Found stone 12x12x5 six inches above ground in good condition marked with 4 groves on east and 2 groves on west sides, with a 3 1/2' by 2 1/2' post driven in ground beside it. Found blazed trees within area. One fir had a K tag. No sign of any B.Ts. Area has been logged.

I followed tree blazes in from creek bottom to the sec. cor. which was well marked. I put silver paint on Basalt stone and orange ribbon on post. Placed a do not destroy sign on 16" fir which is approx. 10-12' from stone. Placed new K tag on 6" fir that is used for sub. pt. Best route in is by following blazed trees from creek bottom.

Used a 6" fir as sub. pt. The bearing to sec. cor is S 68° W 85'.
offset corners - DPA 4/94
3 cards. Some confusion here, Appears to be 2 corners. Hard to distinguish original data from new. Needs reinvestigation. T&H 3/75
BLM reject 5/80

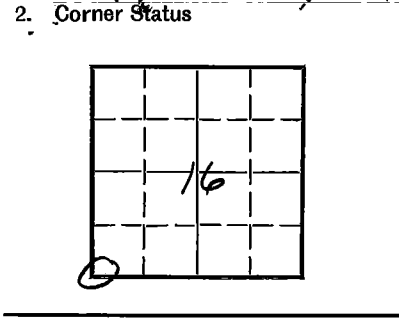
7. Photo Identification
 Photo No. DVD-9M-103
 Ident. By: _____

4. Description of Corners: Basalt stone, 12x12x5" 8" in ground. CC on S face, 4 grooves on E and 2 grooves on W Bearing Trees
A leaning fir, 34" dia bears S88°E 1 Ch 42 lks.
Fir, 6" dia bears S24 1/2°W 43 lks.

Found a rock with 2 grooves on W., 4 grooves on E on West edge of ridge. Set log post 5' high, blazed 2 trees, ~~blazed~~ a 36" PPine on line about 150' due East
