# OREGON CORNER RESTORATION FORM

SECTION 16,17,20,21 TOWNSHIP 4 NORTH RANGE 28 EAST N-9  
 COUNTY : UMATILLA DATE AUG/21

CORNER DESIGNATION  
 SECTION CORNER

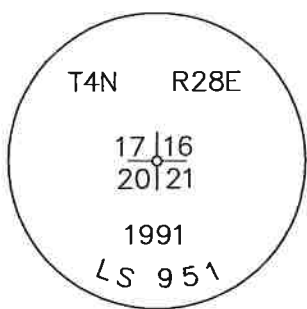
MONUMENT DETAIL

I RECOVERED THE CORNER AND COMPARED ITS LOCATION WITH DUAL MONUMENTATION IN THE AREA AS REQUESTED. PLEASE REFER TO TO RECORD OF SURVEY THAT WAS RECORDED ALONG WITH THIS CORNER RESTORATION FORM FOR MY ANALYSES. THE ACCESSORIES FOR THE CORNER WERE NOT RECOVERED DURING THIS SURVEY DUE TO THE FACT IT HAD NO BEARING ON THE CORNERS LOCATION. PLEASE REFER TO SURVEY NUMBER 19-080-C AND THE CORNER RESTORATION FORMS RECORDED WITH SAID RECORD OF SURVEY FOR ACCESSORY INFORMATION.

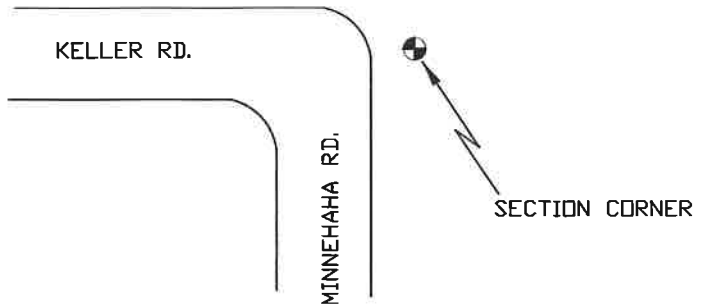
SKETCH

THE CORNER IS AT THE INTERSECTIONS OF KELLER ROAD AND MINNEHAHA ROAD.
