OREGON CORNER RESTORATION FORM

Section 5 Township 3N Range 28E
 County Umatilla Date 07-06-02
 Corner Designation: 3N28A7

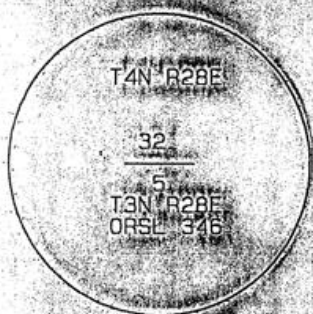
DIAGRAMS

Found the brass cap as described below.

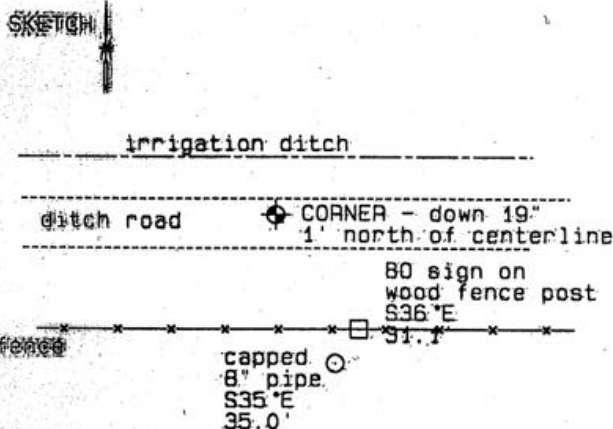
SKETCH

From the junction of I84 and Highway 207, go south on Highway 207 1.9 miles. Turn into a driveway westward and go 0.2 mi. along the bank of an irrigation ditch to a concrete ditch structure. Cross the south side and walk west 0.3 mi. to the corner.
