# OREGON CORNER RESTORATION FORM

SECTION 6,31 TOWNSHIP 4,5 NORTH RANGE 29 EAST  
 COUNTY : UMATILLA DATE MAY/20

CORNER DESIGNATION

1/4 CORNER

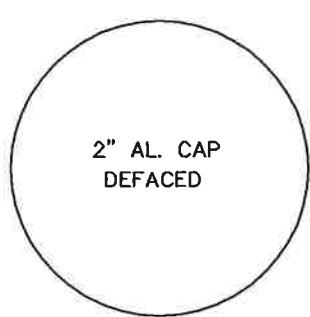
MONUMENT DETAIL

AN ALUMINUM TAG #951 ON A POWER POLE LIES N 19°16'45" W, 39.58 FEET.  
 AN ALUMINUM TAG #951 ON A POWER POLE LIES S 21°44'28" W, 37.01 FEET.  
 AN ALUMINUM TAG #951 ON A POWER POLE LIES S 80°27'01" E, 216.51 FEET.  
 AN ALUMINUM CAP STAMPED AS BELOW.

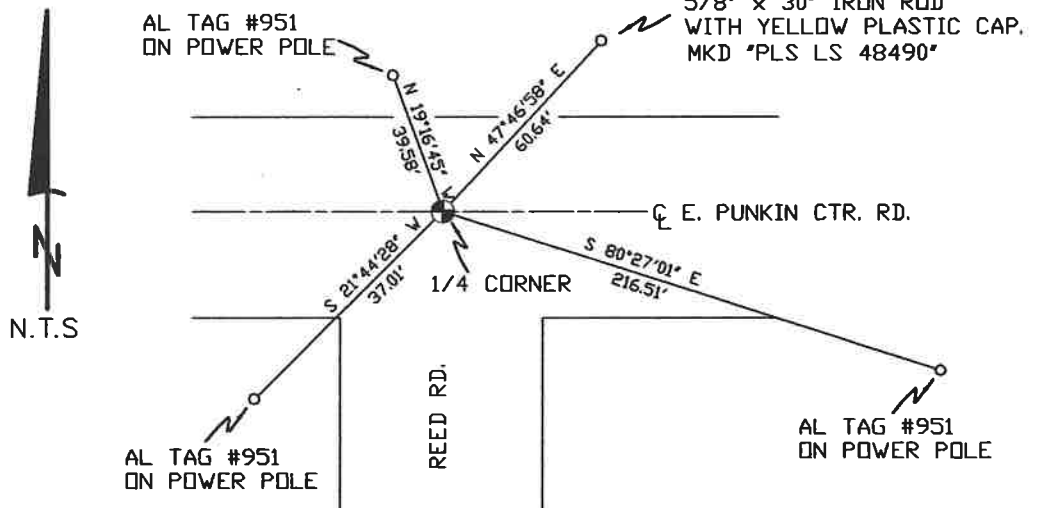
SKETCH

A 5/8" x 30" IRON ROD WITH A YELLOW PLASTIC CAP MKD "PLS LS 48490" LIES N 47°46'58" E, 60.64 FEET.

AT THE INTERSECTION OF REED RD. AND PUNKIN CENTER RD.
