**OREGON CORNER RESTORATION FORM**

SECTION: 11 TOWNSHIP: 4N

RANGE: 29E

NE COR.

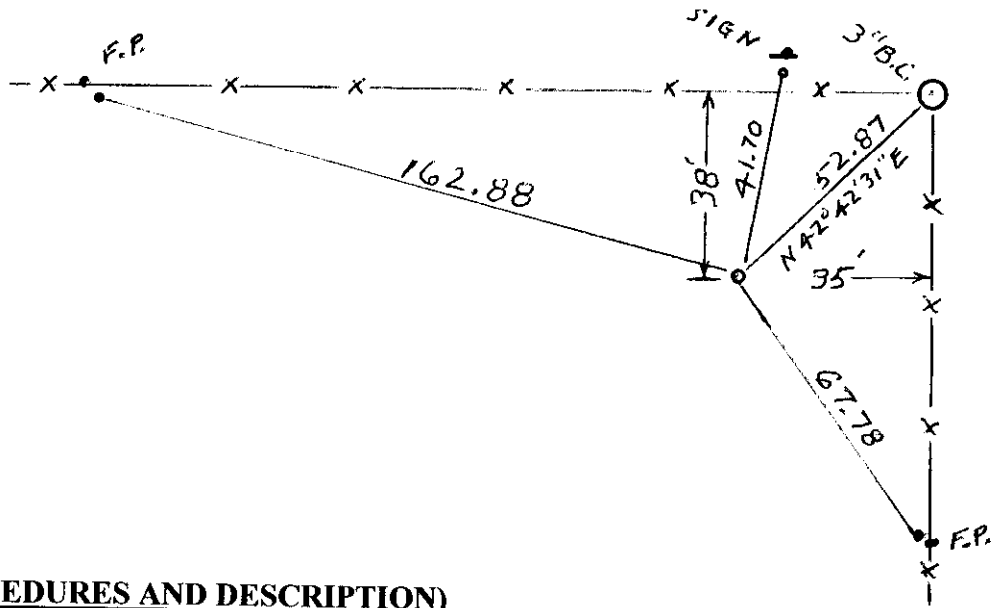
**MONUMENT DETAIL**

T4N R29E  
 S2 | S1  
 S11 | S12  
 2013  
 LS 951

NAD 83/91  
 OREGON STATE PLANE  
 INTERNATIONAL FEET  
 798847.63  
 8547908.05

By double proportion I set a 1" x 15" iron pipe with a 2 1/2" brass cap 24" below the surface of a cultivated field stamped as above and poured concrete around it.

- A 3" Iron Pipe with a 3" brass cap stamped 1934 U.S. Dep. of Agri. bears N 42° 42' 31" E 52.87'
- A 5/8" x 30" Iron Rebar with plastic cap #951 bears N 14° 19' 10" E 41.70'
- A 5/8" x 30" Iron Rebar with plastic cap #951 bears N 76° 44' 34" W 162.88'
- A 5/8" x 30" Iron Rebar with plastic cap #951 bears S 30° 16' 34" E 67.78'
