CORNER RECORD (SEARCH)
(Ref. FSM 7151.4)

Tract or
Survey No. 4-148 Cor.
No. R-19

T 4S R. 30E

R.D. Ukiah County Umatilla

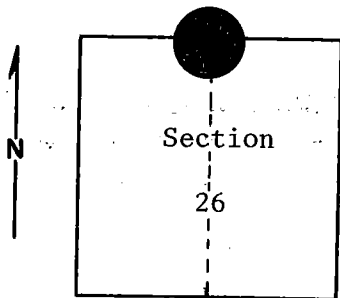
CORNER DIAGRAM

Monumented by BLM, 1978 (R.M.'s)
No markings. Location falls exactly in bottom of stream bed.
Stream flows over it during run-off. There are many stones.

A 24-inch p.pine bears N34°W, 14 feet. Scribed ¼ S, B.T. It has an old location poster and an old "Attention" poster. It grows on edge of stream bank.

An 18-inch p.pine, down and rotting, bears S44°W, approximately 20 feet. Scribed ¼ S, B.T. Its up-root lies at south edge of stream bed.

The stream, in which ¼ corner lies, flows nearly due east. A primitive road crosses this stream approximately 400 feet east.

I placed blank B.T. tags on the two B.T.'s.

I also placed a location poster on a 50-inch white fir at east edge of road approximately 400 feet east of 1/4 corner (where road crosses stream).
