OREGON CORNER RESTORATION RECORD

SECTION 34 TOWNSHIP 6 N RANGE 35 E.W.M.
SECTION 3 TOWNSHIP 5 N RANGE 35 E.W.M.

DESCHUTES COUNTY DATE 06/14/2013

CORNER CODE T5N R35E A15
T6N R35E Z15

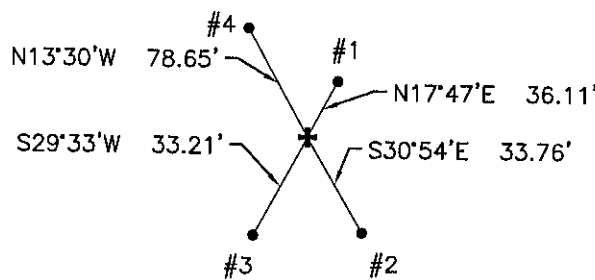
SKETCH

NO EVIDENCE OF THE ORIGINAL CORNER WAS FOUND A 2 1/2" BRASS CAP IN AN ALUMINUM MONUMENT CASE ON THE EASTERLY EDGE OF COUNTY ROAD, SET BY TOMKINS PER LCR 91-81-B BEARS N17°46'53"E 36.11 FEET.

AT THE CORNER LOCATION SET A 5/8" X 30" IRON REBAR WITH A 1 1/2" BRASS CAP STAMPED T6N R35E 1/4 S34/S3 T5N R35E 2013 PLS 02820 2" BELOW THE ASPHALT SURFACE IN THE CENTER OF COUNTY ROAD. THE MONUMENT IS SURROUNDED BY A RING OF CONCRETE 12" IN DIAMETER AND 12" THICK.

- #1) A 2 1/2 BRASS CAP STAMPED PER LCR 91-81-B AND 03-23-C BEARS N17°47'E 36.11'.
- #2) A 5/8"x30" IRON REBAR WITH A YELLOW PLASTIC CAP STAMPED "USKH 02820" ATTACHED SET ADJACENT TO THE NORTHWESTERLY SIDE OF A STEEL POWER POLE BEARS S30°54'E 33.76'.
- #3) A 5/8"x30" IRON REBAR WITH A YELLOW PLASTIC CAP STAMPED "USKH 02820" ATTACHED SET ADJACENT TO THE NORTHEASTERLY SIDE OF A WOOD POWER POLE BEARS S29°33'W 33.21'.
- #4) A 5/8"x30" IRON REBAR WITH A YELLOW PLASTIC CAP STAMPED "USKH 02820" ATTACHED SET ADJACENT TO THE SOUTHEASTERLY SIDE OF A WOOD POWER POLE BEARS N13°30'W 78.65'.
