USDA-FOREST SERVICE

Index
 File No. T-21
 T 58 R. 30E
 Merid. W.M.

CORNER RECORD (SEARCH)

N. Pk. (Ref. FSM 7151.4) Tract or Survey No. _____ Cor. No. _____
 R.D. John Day County Umatilla
 N.F. Umatilla State Or.

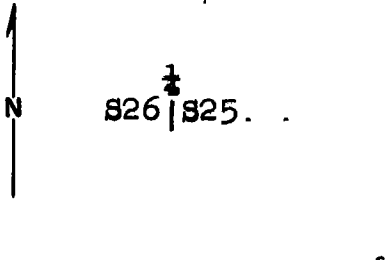
CORNER DIAGRAM

DESCRIBE CORNER MONUMENT FOUND
2 1/2" iron pipe with 3 1/4" brass cap mkd.:
 T58 R30E
 1/4
 826 | 825
 1978
 BLM

DESCRIBE BEARING TREES OR OTHER OFFICIAL ACCESSORIES FOUND
D.. Fir, 21", N37 1/2 W, 79.2'; with healed blaze.
P. Pine, 20", S40 0 E, 9.9'; with healed blaze.

DESCRIBE CORNER LOCATION RELATIVE TO NEAR-BY FEATURES, ALSO HOW TO REACH CORNER
Cor. falls on NELY slope, E of fence. Posted line N and S..

P. Pine, 12", N72°E, 45.4'; mkd.: X BT

D. Fir, 9", S63 $\frac{1}{4}$ °W, 31.6'; mkd.: X BT

BTs have red blaze, band; BT tags and 54-9 signs. New BTs also have alum "PLS 1832" washers. 6' fence post with 54-4 sign within 5' of cor.
