CORNER RECORD (SEARCH)  
(Ref. FSM 7151.4)

Index  
File No. R-13

CORNER RECORD (SEARCH)

T 5S R. 33E R.D. Ukiah County Umatilla  
Merid. Willamette N.F. Umatilla State Oregon

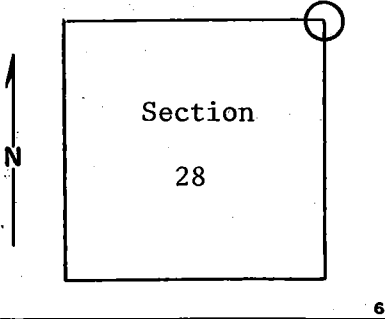
CORNER DIAGRAM

Material: None.  
Corner location appears to be on north bank of Hidaway Creek, near toe of 10 to 20 feet below pipe arch outlet.  
*Road fill, about*

No evidence of B.T.'s.  
Location poster or stump on north bank of creek approximately 10 feet below pipe arch outlet.  
Location poster on down tree about 30 feet below pipe arch outlet. Tree has uprooted from north edge of creek and fallen south across creek.
